**QUALITY MANAGEMENT DURING IN-SITU  
RECONSTRUCTION OF FAILED SICKLE PLATES  
BY WELDING AT UNDERGROUND PENSTOCK  
OF SRISAILAM LEFT BANK HYDRO ELECTRIC  
PROJECT – A CASE STUDY**

By  
Rama Dasu Pittala

**A DISSERTATION**

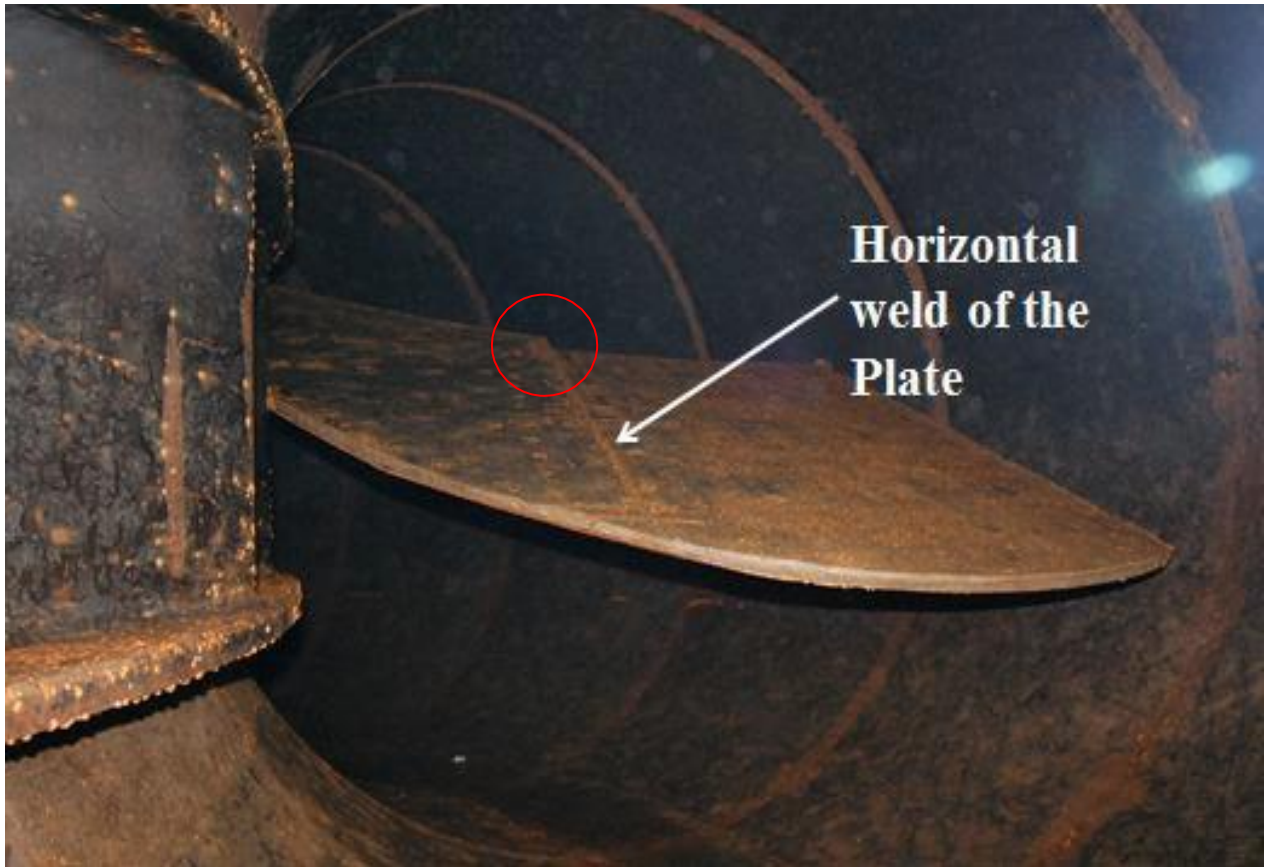
On 11<sup>th</sup> Oct 2008 around 6.00Am, heavy vibrations were observed in Unit 2 during service. Draft tube was emptied and when examined inside, part of Sickie-plate at bifurcation between Units 2 & 3 was found stuck-up in the spiral casing of Unit 2 . ( Ref Fig.1 )

Fig.3[1].Part of Sickle Plate found in Spiral casing of Unit 2. Geometric Stress raiser seen at the location marked with **Red Circle**.

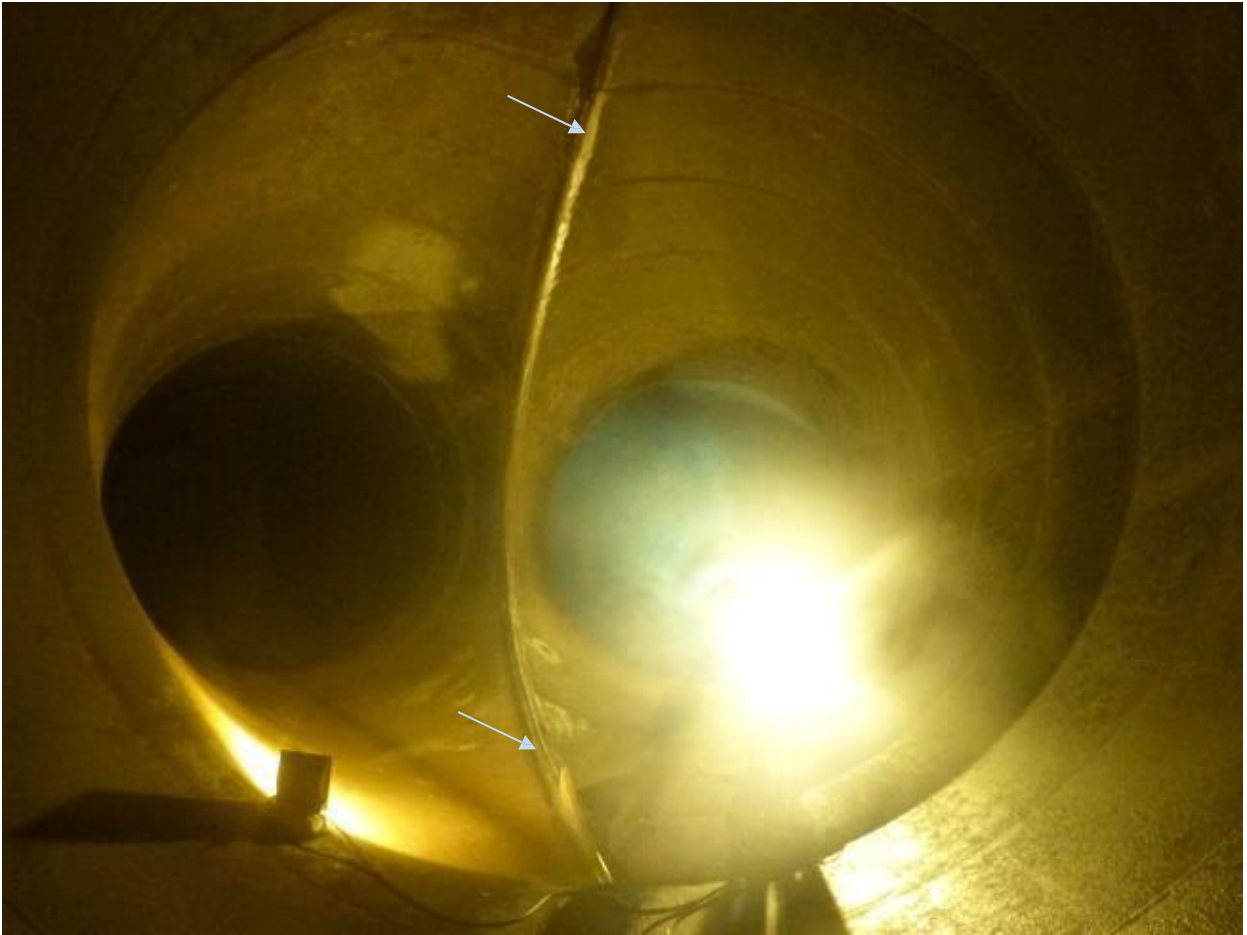
The fracture plane observed at bifurcation Joints 2 and 4 was identical. [4]

Fig.4[1] – Fig.1 - Showing Fracture plane at bifurcation between Unit 5 &6, which is very rough and un even.

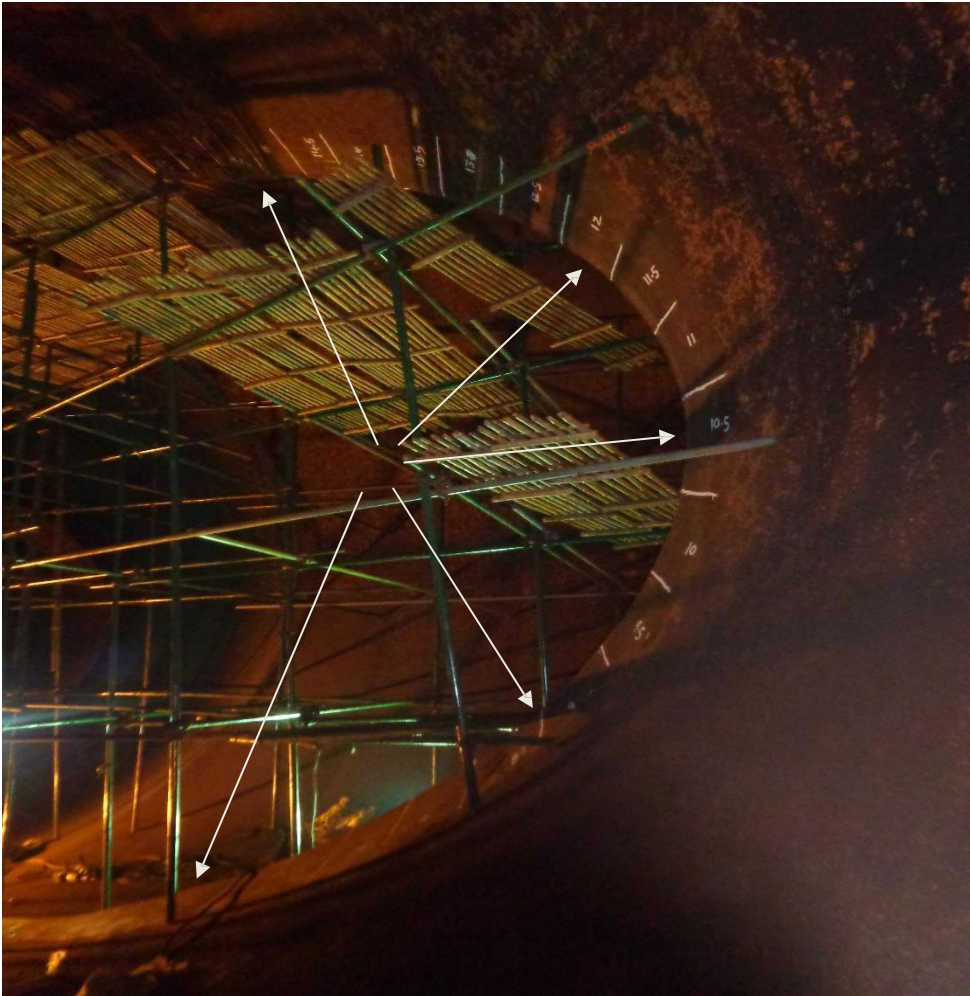
Fig 5[4] Rectified fracture plane , before welding new sickle plate

As suggested by the expert committee, the fractured surface of remaining portion of buried sickle plate was smoothed by Cutting / Grinding and weld metal deposition.

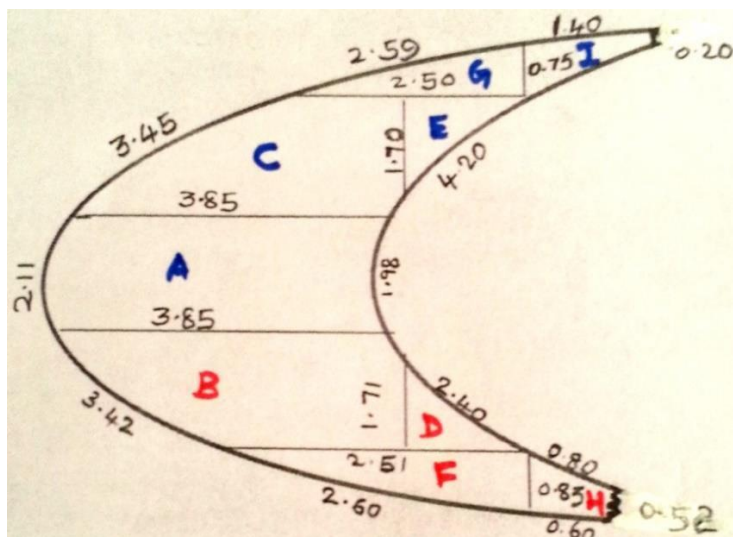
Fig.6 . Failed Sickle Plate at Bifurcation between Units 2 & 3 ( ACEGI: Found in Spiral casing of Unit 2, BDFH : Found in pressure shaft 1 sump).

Design inadequacy, Operational Imbalance, Geometric / Metallurgical Stress raisers at the inner curve of Sickle Plate, presence of Lack of Side wall fusion of Longitudinal Weld etc. might have contributed for the failure. [4]

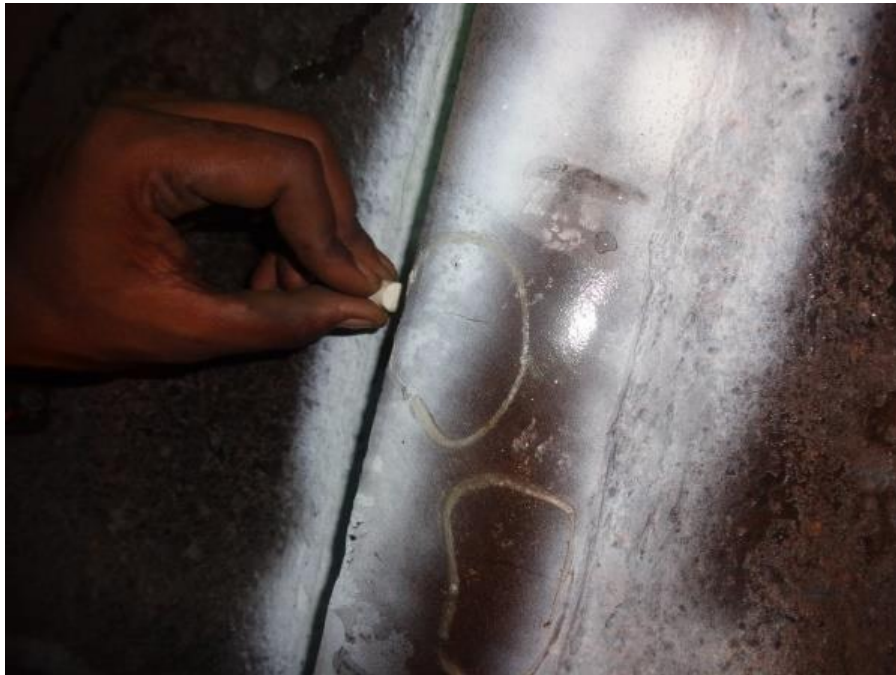
Incase of Bifurcation Joint No.4, 9 Nos of transverse cracks were found.

Fig.11A- Transverse cracks found during MT of Remaining Sickle Plate .

All such cracks were removed by grinding up to sound metal and repeat MT using dry particles carried out. (Refer Fig 12.A). This has resulted in improper root gap and irregular surface of K joint profile. This location has been weld repaired and proper root gap ensured prior to commencement of Part 1 welding.( Ref. Fig 12.B ).

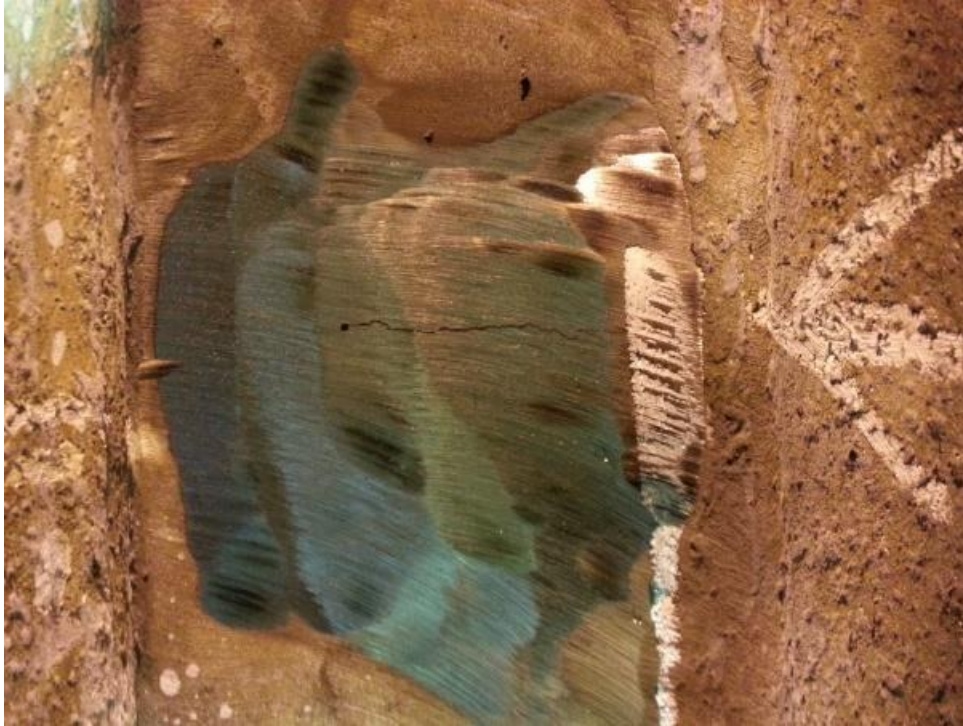
Fig.11B- Appearance of Transverse crack after grinding 8mm deep.

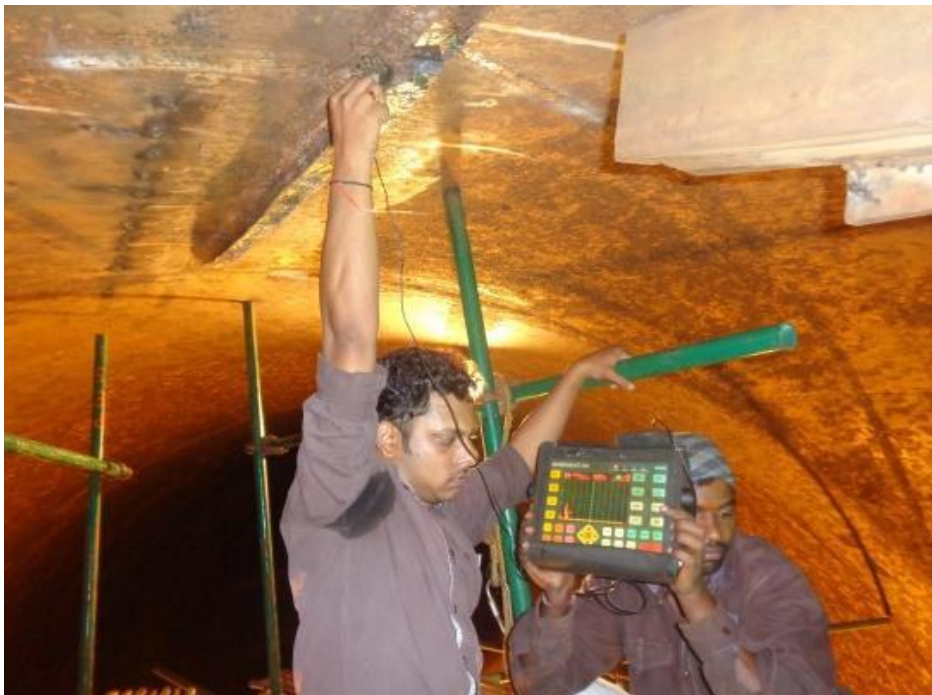
In addition to the transverse cracks, lamination of about 500mm long was found during ultrasonic examination of remaining sickle plate portion at overhead position, Chainage 18.5 to 19.0 at bifurcation joint No.4.

11C- Lamination found in UT at Chainage 18.5 – 19.0.

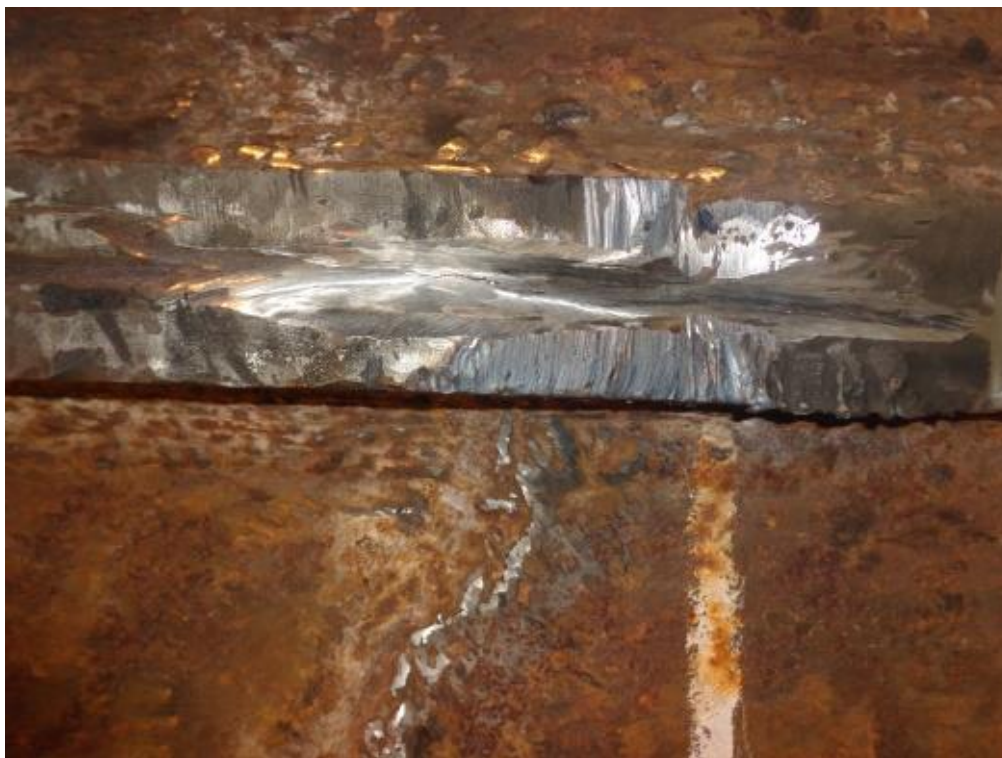
11D-same location after grinding to remove lamination

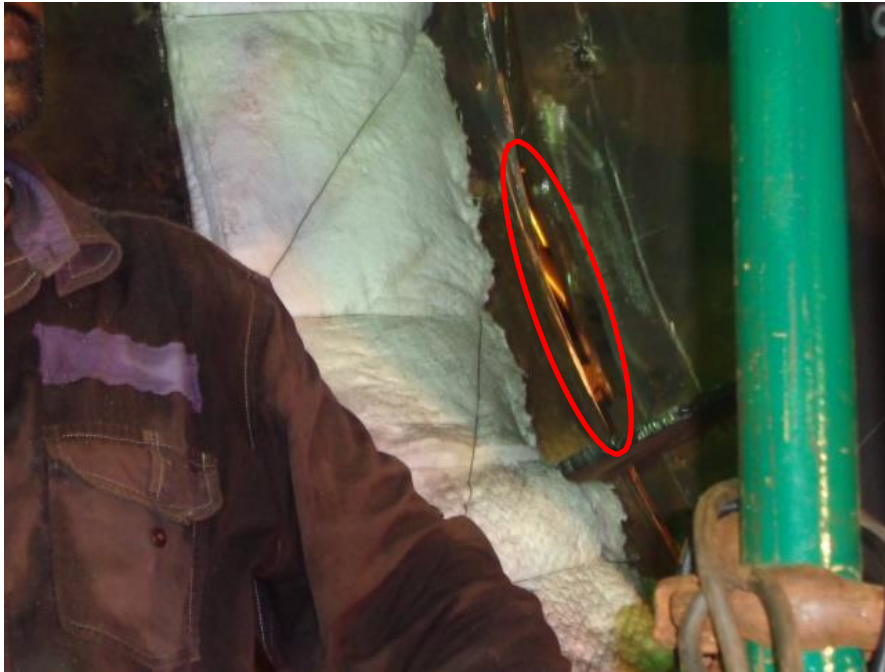
Fig.12A-Transverse cracks removed by grinding., resulting in uneven root gap.
