**Modular Integrated Construction (MiC) for
High-rise Public Residential Housing in Hong
Kong: its Building Design, Construction, and
Maintenance Management**

A THESIS

Faculty of Engineering & Technology
in fulfillment of the requirements
for the degree of Doctor of Philosophy
in Construction and Real Estate Management
2025

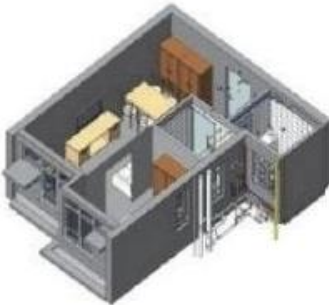
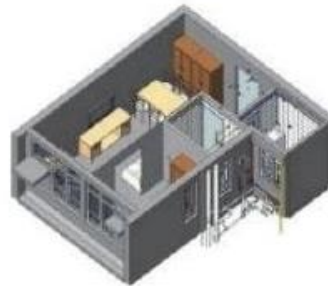
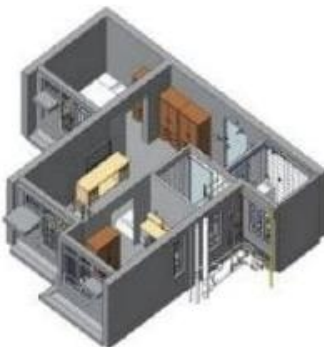
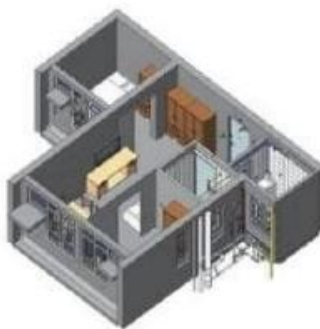
Fig. 3 Modular flats

2-person/3-person flats

Family Flat

1-bedroom flats

2-bedroom flats

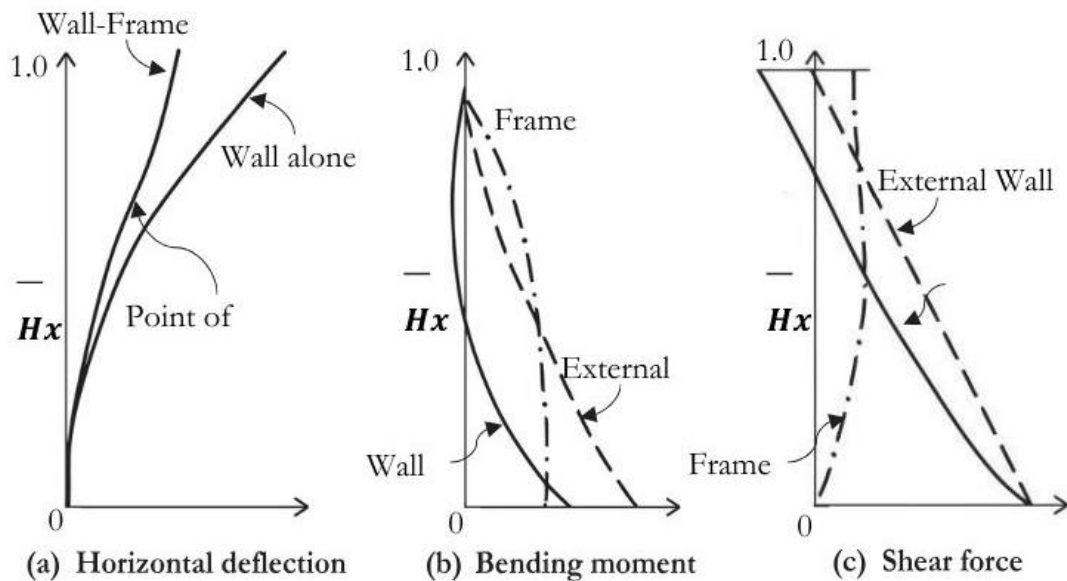
Fig. 7 Frame wall system bending moment and shear force

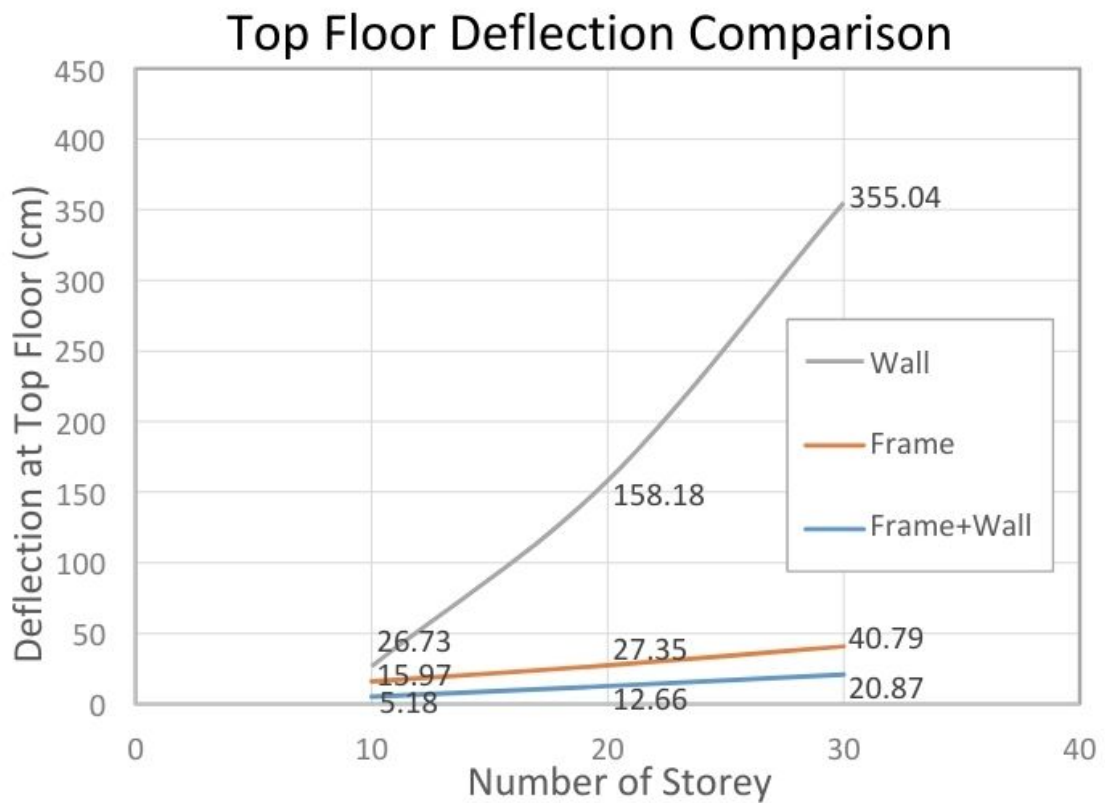
Fig. 18 Top floor deflection comparison for the case studies

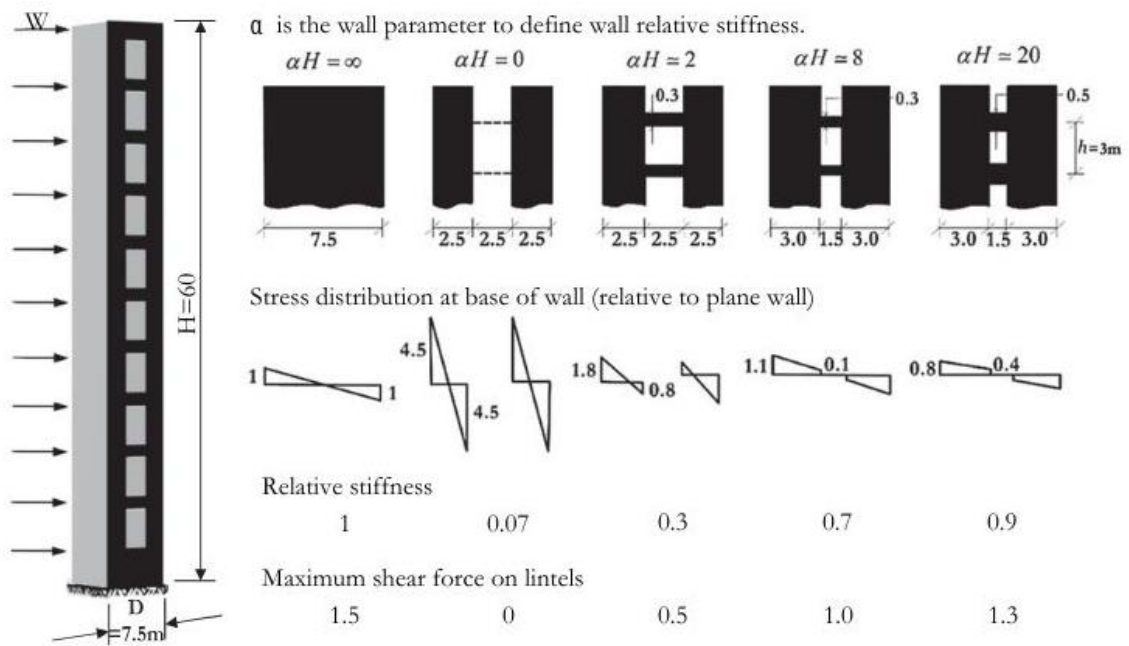
Fig. 21 Relative properties of various wall geometries

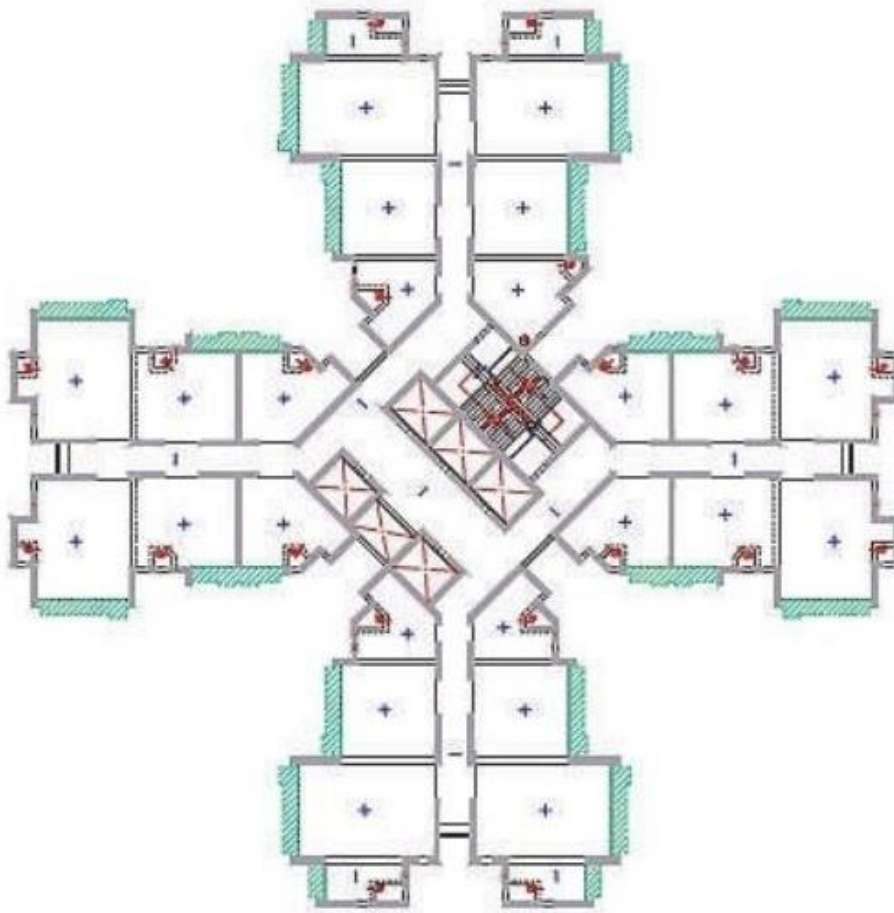
Vertically, the end gable walls and the walls further from the central core are more effective in resisting the vertical bending moment to the block due to lateral wind (see Fig. 26). As a result, the end gable walls are normally made thicker than the other walls. On the other hand, the central lift cores are less effective. When the block has long corridor, the corridor spine walls are also very effective in resisting wind bending moment.

Fig. 26 End gable walls and walls further from centre better resist vertical bending moment

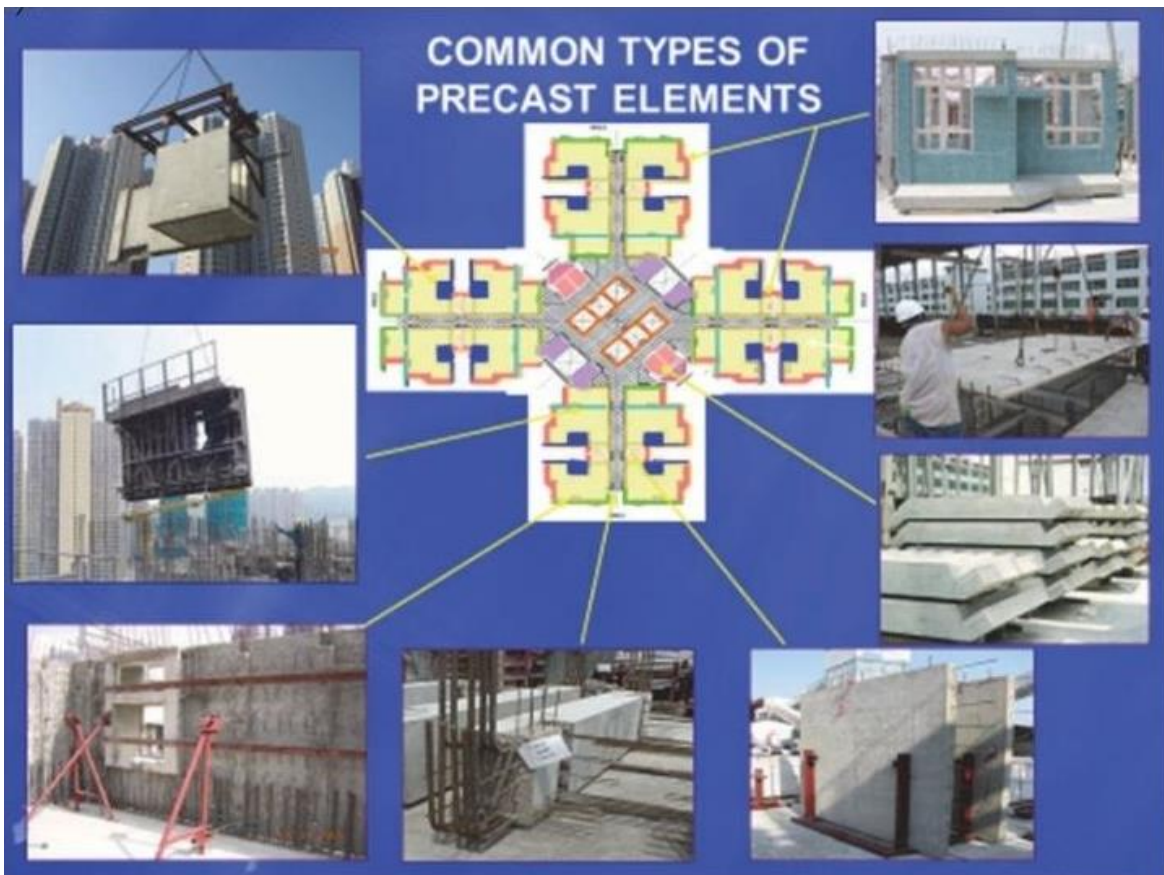
Fig. 29 Common types of precast elements

With the use of standardized modular flats in public housing, the building skeleton components such as facades, slabs, staircases, partition walls, beams and bathrooms are prefabricated (see Fig. 29). Prefabrication of concrete components is essentially the construction method which transfers some of the difficult insitu reinforced concrete construction from working floor to factory. The transfer is also from elevated construction on site to construction on ground in factory (see Fig. 30).

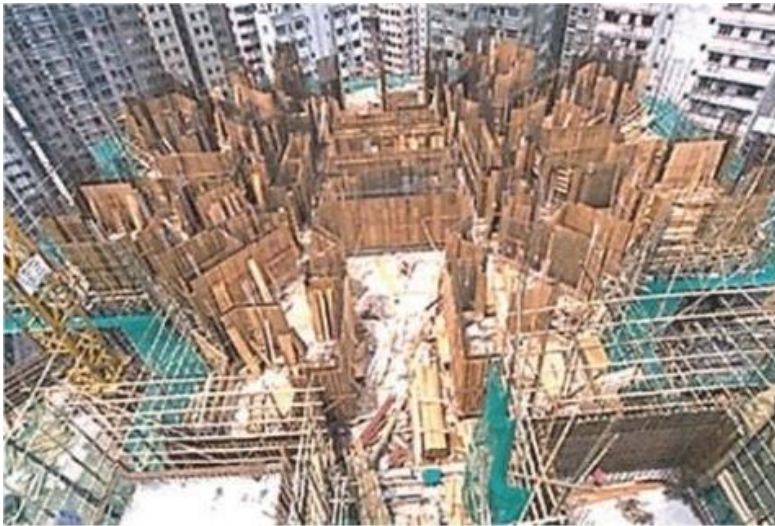
Fig. 31 Traditional method of construction

For elevated construction, it is often difficult to handle complicated component profiles or locations which are difficult to access. Substantial falsework and working platforms may be required (see Fig. 31). In case timber formwork is used, the workmanship may be deteriorated after repetitive construction. For factory fabrication on ground, steel moulds can be used which facilitates horizontal casting of concrete and steel fixing (see Fig. 32).

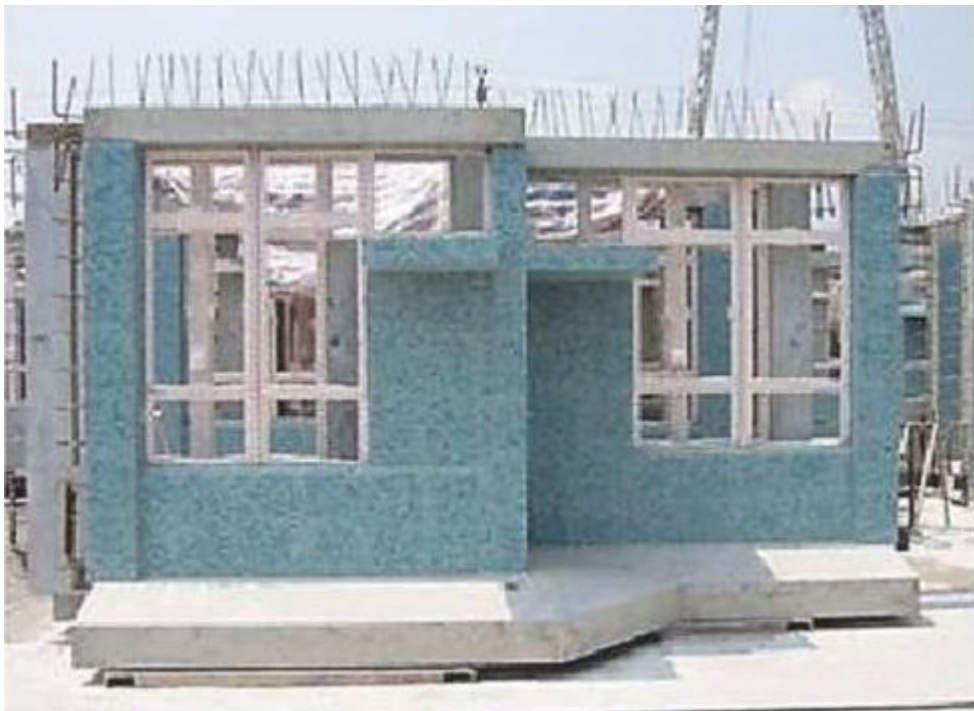
Precast facade (see Fig. 33) is a typical example where casting at elevated position is difficult, whether it is cast together with the working floor construction or after the structural skeleton is cast using insitu method. On the other hand, if the complicated profile is tackled on ground in the factory, it is much easier. The facade is cast horizontally in factory (see Fig. 34) like a slab instead of like a wall for insitu construction. Moreover, in the factory, the window frame can be cast into concrete which can prevent water seepage in the long run. The surface finishes can also be applied on ground instead of applying by scaffolding or working platform at height.

Fig. 33 Precast facade

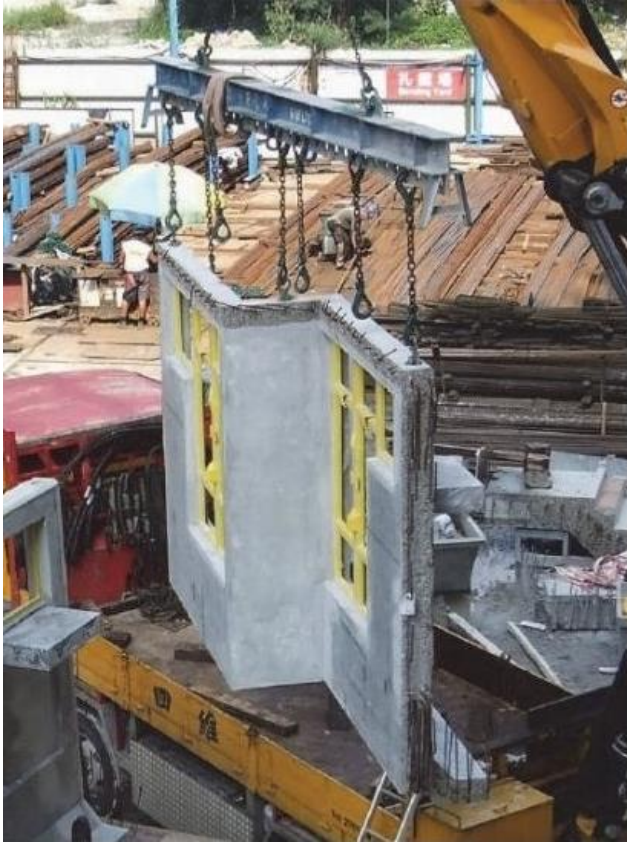
During the manufacturing and erection stages, the facade is required to be lifted up and transferred (see Fig. 37). The lift up loads need to be designed for so that the concrete sections will not be damaged or cracked. A common practice is to use a lifting frame so that the lifting wires can be kept vertical instead of inclined, hence no horizontal component of the lifting force will be exerted upon the concrete sections which creates undue stresses.

Fig. 37 Façade showing the lifting frame

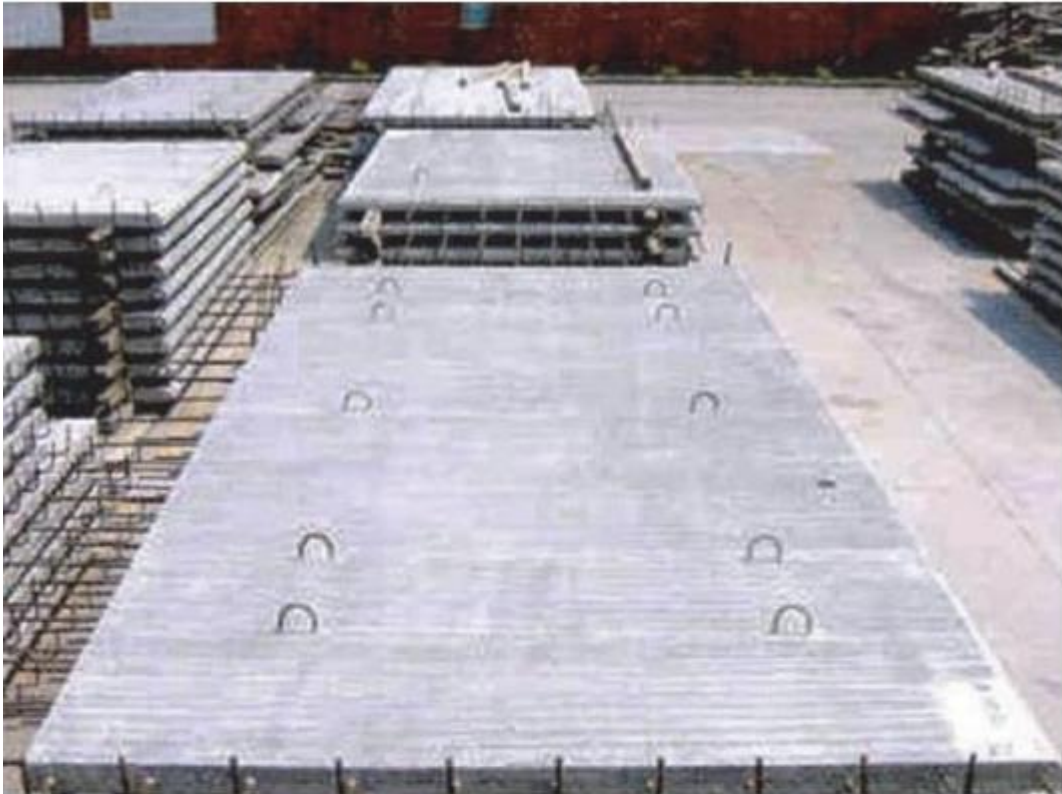
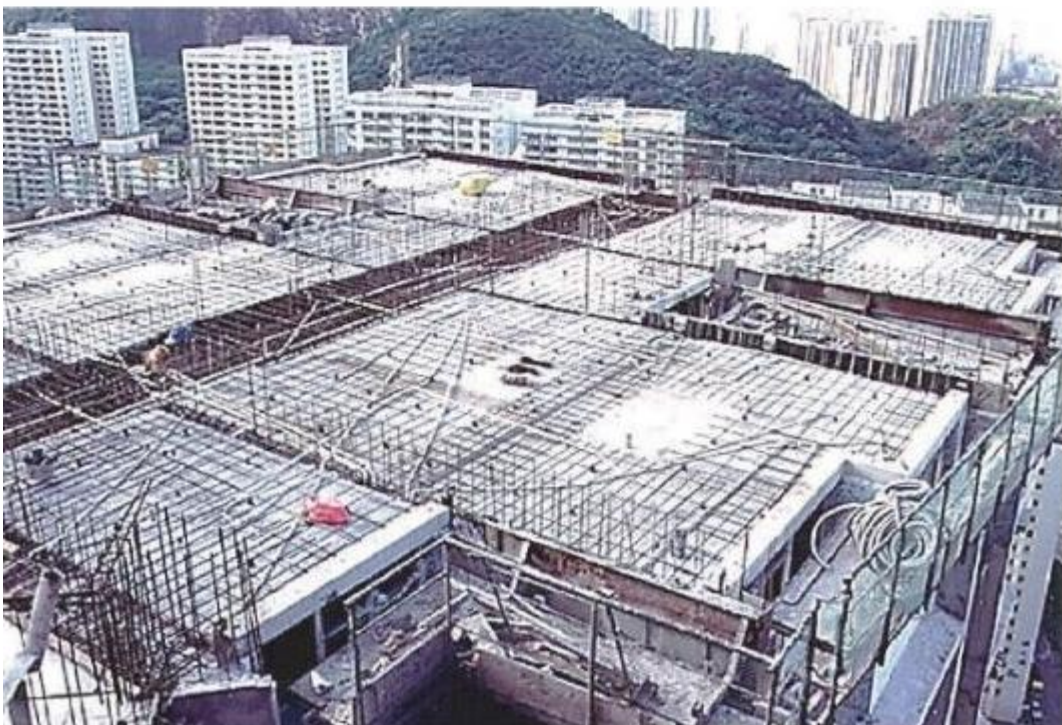
Semi-precast slab (see Fig. 38) is a composite construction method whereby the lower portion is precast done in the factory and the upper portion is cast in-situ. The benefit is that the slab soffit is now very smooth and needs no touching up and it also serves as formwork for casting the upper portion. No slab formwork is hence required on site. The construction is much neater and less labor on site will be deployed.

Fig. 38 Semi-precast slab

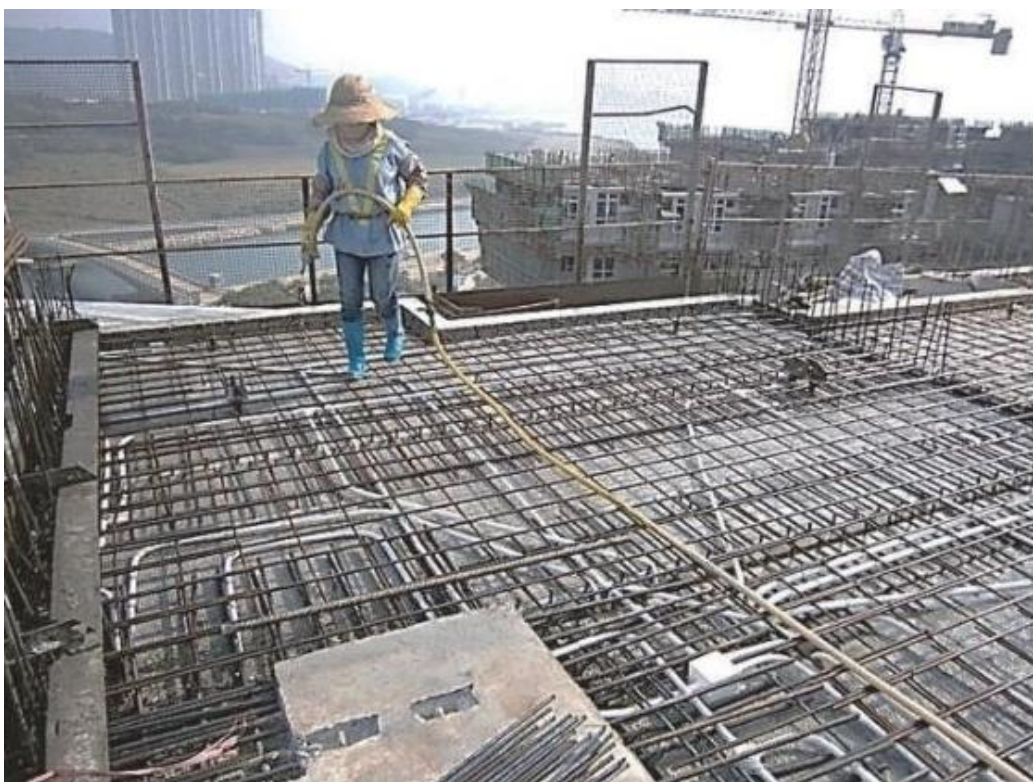
Reinforcement laying for the in-situ portion is also very convenient, simply laying a few sheets of fabric reinforcement on top of the precast planks (see Fig. 40). Much less labors is deployed as compared with traditional method.

Fig. 40 Laying of electrical conduits and fabric reinforcement on top of semi-precast slab

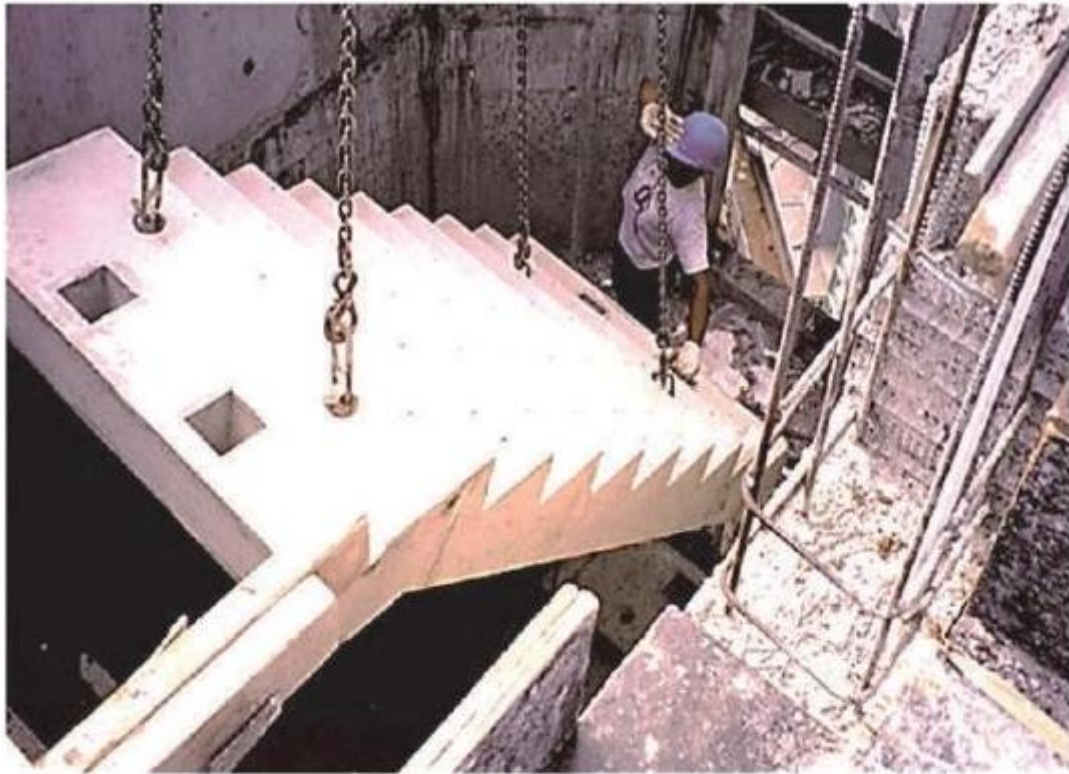
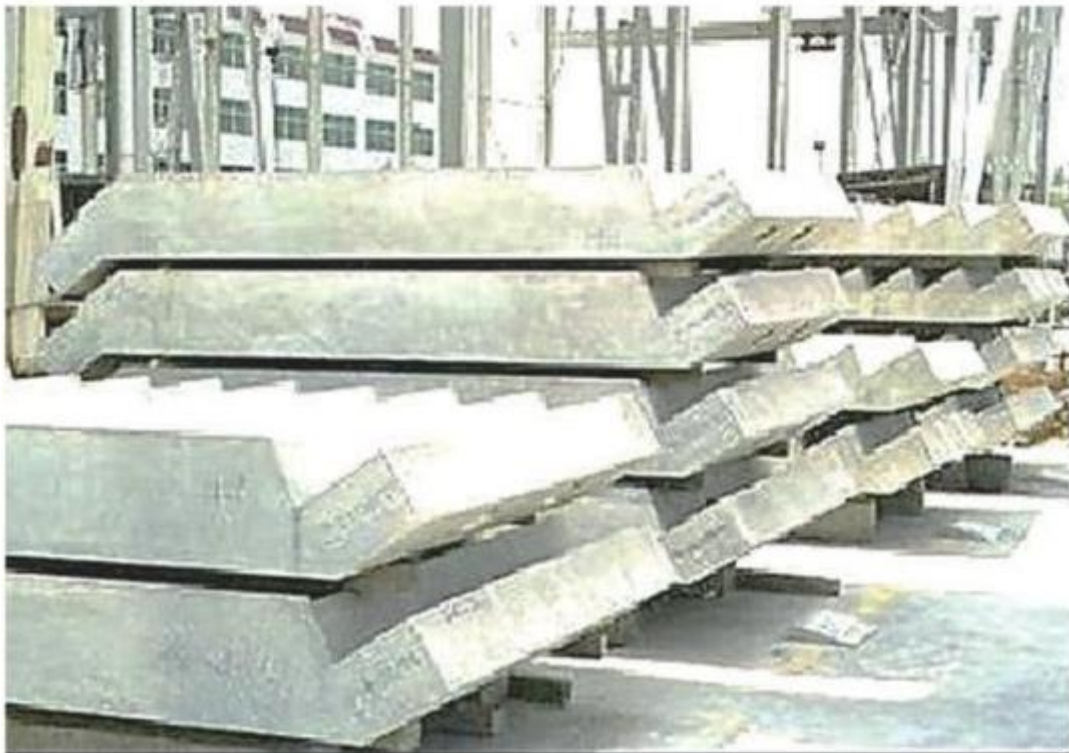
Fig. 42 Precast staircase

Staircase in residential building is normally confined in a limited space within the stair core. In-situ construction is difficult because of the need for erecting formwork and falsework within the confined space, reinforcement fixing and concreting. It is sometimes even dangerous due to the possible movement of falsework by workers' passage up and down before the cast concrete has reached the necessary strength to facilitate falsework removal.

Precast staircase is simple to produce in factory and easy to install on site. Connection at supports are made by dowel bars and box-outs, to be grout filled afterwards (see Fig. 43).

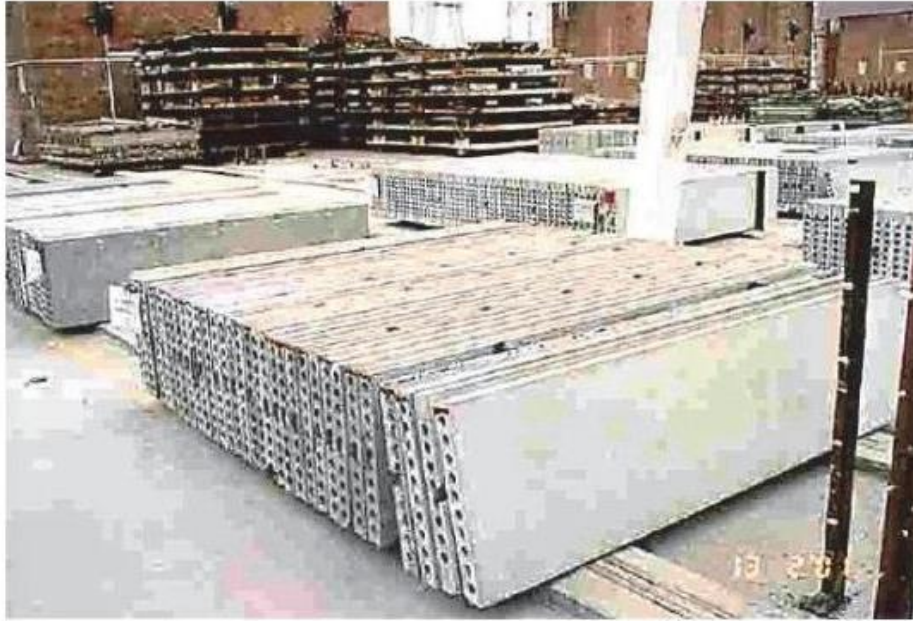
Fig. 45 Lightweight concrete wall

There are two types of partition walls, one is by lightweight concrete and the other is by reinforced concrete. Lightweight concrete wall (see Fig. 45) is used for internal partitions, such as toilets, kitchens, etc. They are made by either hollow sections or aerated concrete. Lightweight partitions are to be erected after construction of structural frame, to serve as partitions but eliminate wet trade (previously by blockworks).

The partition wall is first erected up vertically, then jacked up by wedges at the bottom of the wall and afterwards filled up the bottom gap with cement mortar.

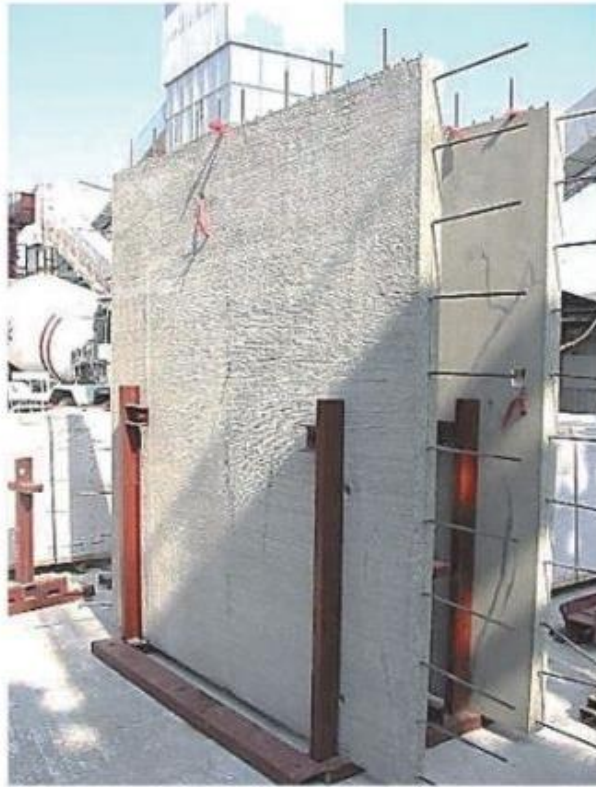
Fig. 46 R.C. partition wall

R.C. partitions (see Fig. 46) are normally used for partitioning between two flat units, for the reasons of fire protection and security. They are thin partitions which are difficult to be constructed vertically by in-situ method. These walls can be cast horizontally in factory.

The erection of RC partition wall shall be carried out by tower crane before construction of the floor slab above. The top of R.C. partition is anchored into the upper floor slab with reinforcement. This is to better stabilize the wall for security reasons.

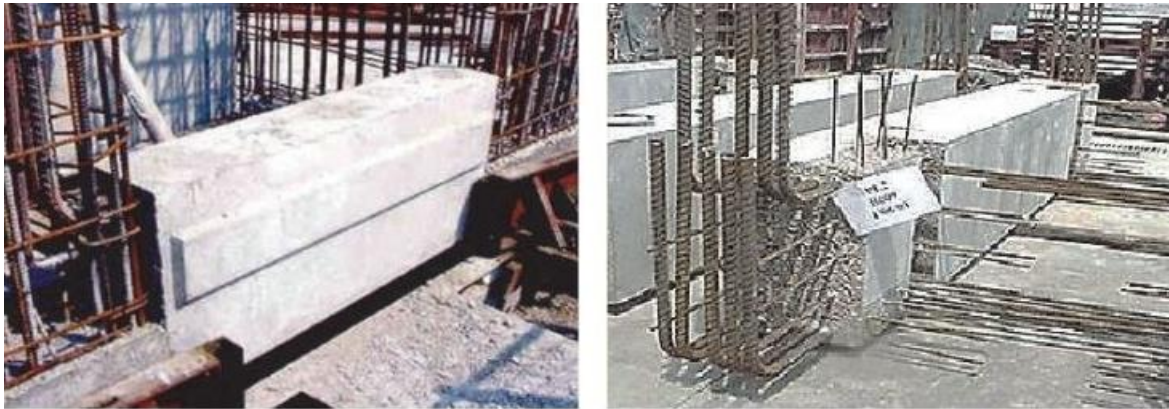
Fig. 47 Precast tie beam

Tie beams are often provided to better transfer the horizontal shear at locations such as re-entrants. The tie beams are usually very short beams, but do not have floor slabs on either side of the beams. As a result, it is difficult to construct the beam at elevated position unless substantial temporary working platform and falsework are erected. With the use of precast tie beams (see Fig. 47), the construction will be very simple. The projected reinforcement at both ends of the tie beam can rest upon the construction joint on the top of the wall as temporary supports and the tie beam can be cast into the permanent wall supports on either sides.

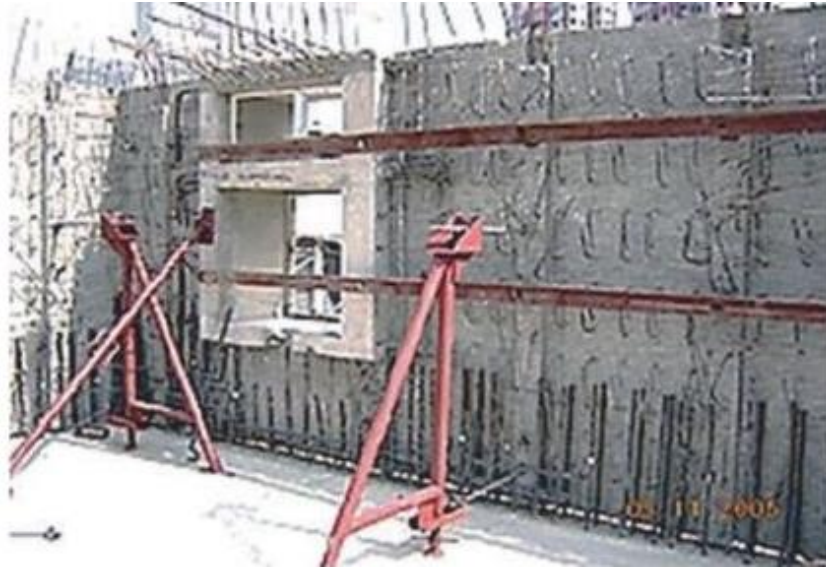
Fig. 48 Semi-precast wall

Semi-precast walls are usually installed at the end gable wall or re-entrant wall locations (see Fig. 48). The purpose of the wall is to allow external finishes such as tiles to be applied in the factory and on ground instead of at elevated positions on site which saves the setting up of scaffolding and/or working platform to do so. The semi-precast wall serves as a sacrificial skin like a formwork and is later connected to the permanent structural wall. This type of semi-precast wall is sometimes called the lost form. It has also the added benefit of not requiring workers to work outside the building (working at height) and hence better safety for workers.

The semi-precast wall has shear keys (reinforcement) for anchoring into the permanent wall. It is first erected with inclined supports and later on the permanent wall reinforcement and steel formwork are installed for casting of concrete.

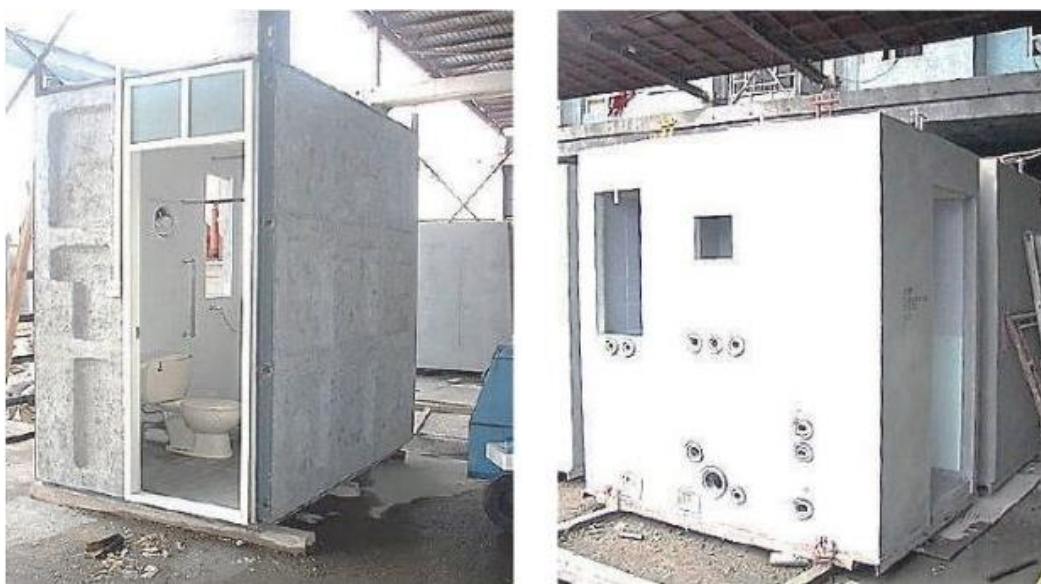
Precast bathroom (see Fig. 49) is a box-type structure which embodies numerous pipe ducts, fittings, tiles, waterproofing membranes, etc. The purpose is to transfer a lot of wet trade to the factory which is a better controlled working environment. From past experience, bathroom areas are locations which call for frequent maintenance throughout their life spans because of concrete spalling, water seepage at floor, pipe leakage, etc. With better quality assurance in factory and on ground, the aforesaid workmanship problems can be substantially eliminated.

Fig. 49 Precast bathroom

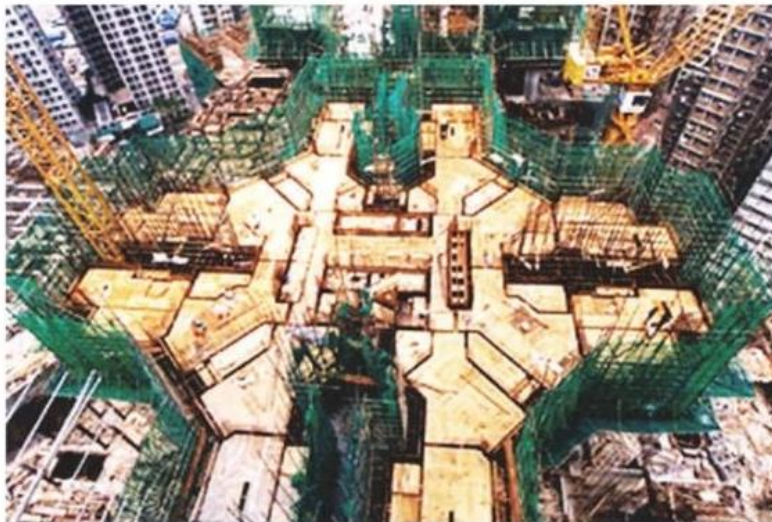
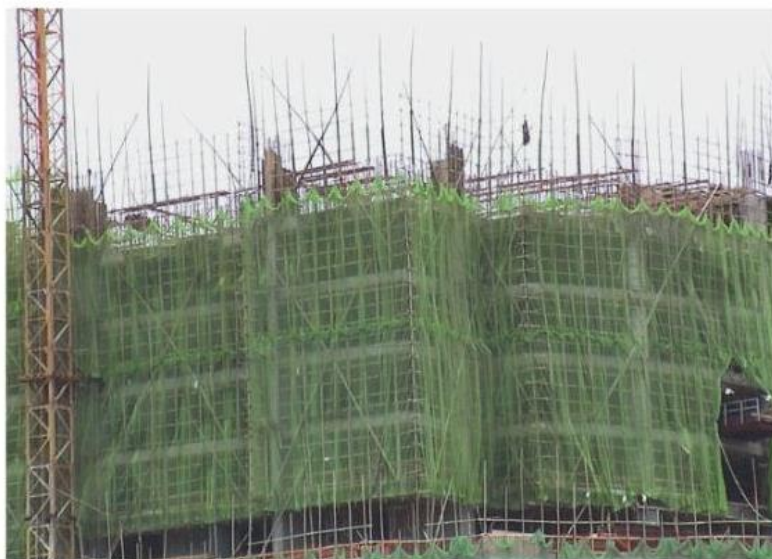
Fig. 50 Traditional construction

For elevated construction using traditional methods, it is often difficult to construct at locations which are difficult to access. Substantial falsework and working platforms may be required. In case timber formwork is used, the workmanship may deteriorate after repetitive construction (see Fig. 50).

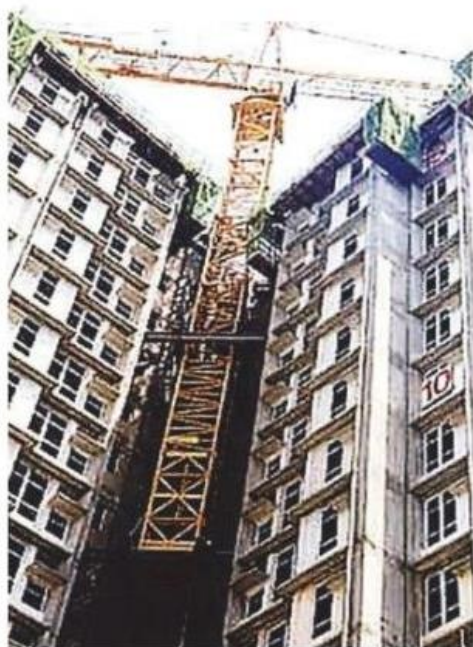
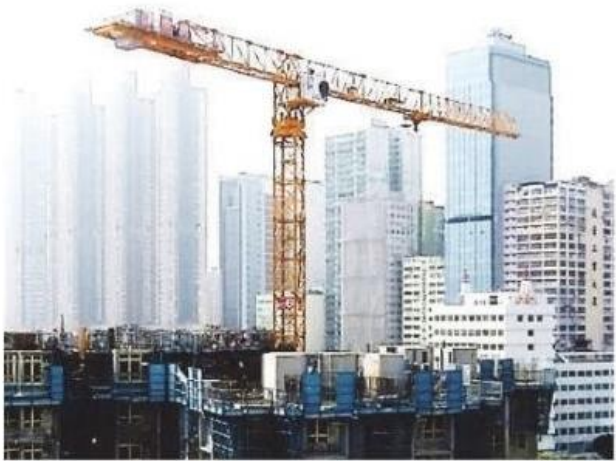
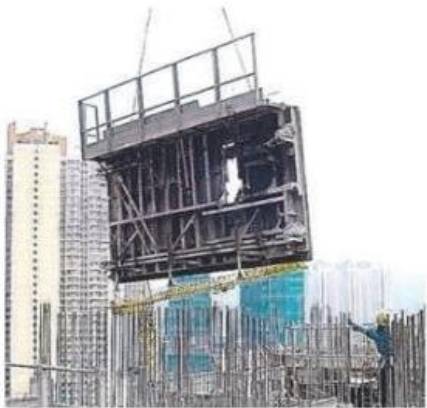
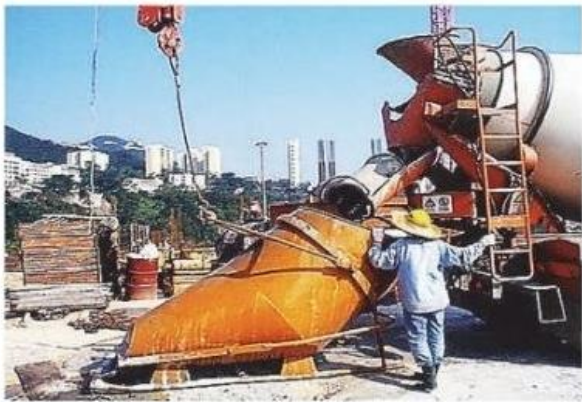
Fig. 51 Mechanization construction

Mechanized construction comprise primarily the use of tower crane to move around steel formwork, concrete skips and precast components. The transportation is between ground and working floor and between different wings of working floors (see Fig. 51).

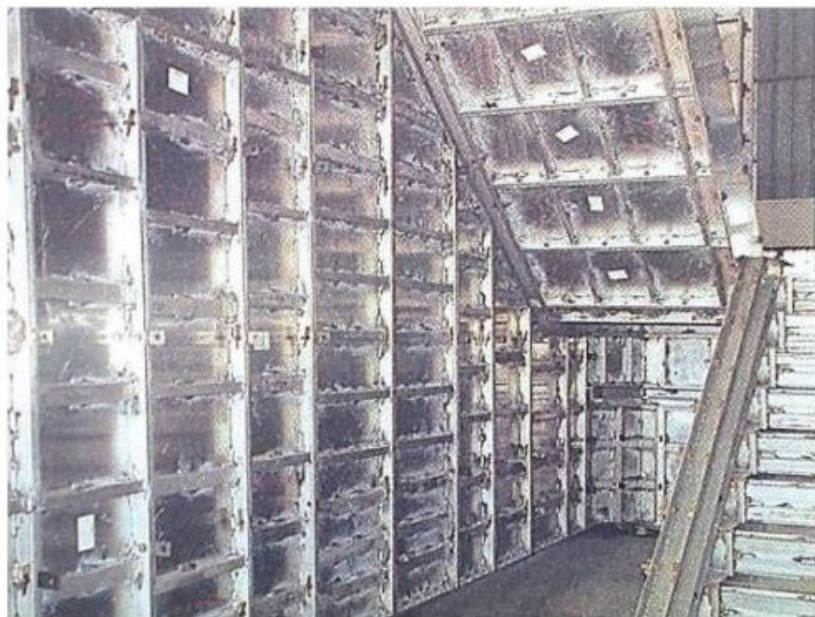
Aluminium formwork panels are smaller in size, normally 600 mm in width. They are assembled into one big panel piece by connecting with bolt joints (see Fig. 54). As a result, they are more flexible in fitting different shapes and dimensions. They are transported and assembled by manual labours because of their smaller sizes.

Fig. 54 Aluminum formwork

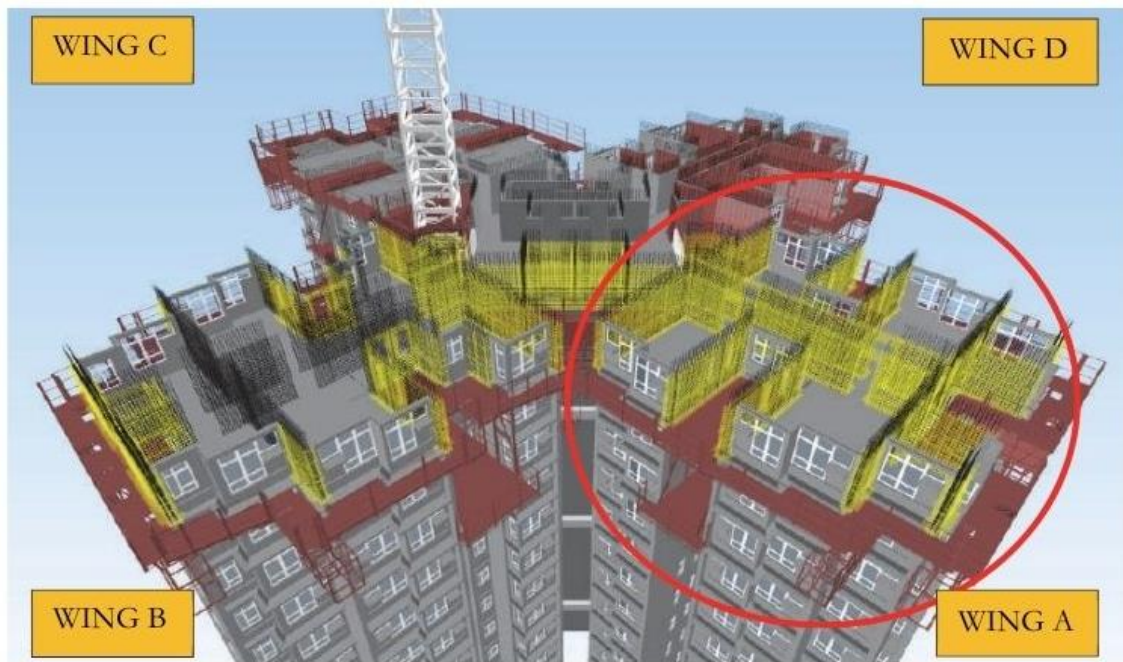
Fig. 59 Day 4 activities

- i) Wing A - Erect precast facades (100%). Fix wall reinforcement (100%). Install wall formwork (100%).
- ii) Wing B - Erect precast facades (100%). Fix wall reinforcement (100%). Install wall formwork (30%).
- iii) Wing C - Dismantle wall formwork (100%). Lay semi-precast slabs (100%).
- iv) Wing D - Dismantle wall formwork (30%).

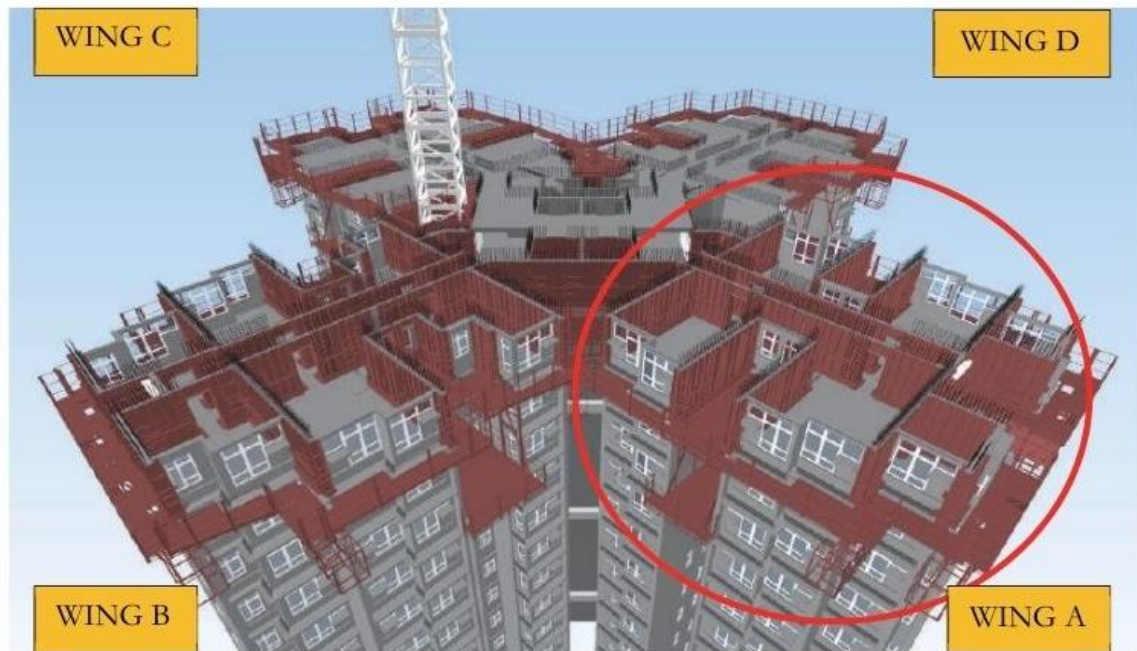
Fig. 61 Day 6 activities

- i) Wing A - Dismantle wall formwork (10%).
- ii) Wing B - Concreting walls (100%).
- iii) Wing C - Lay fabric reinforcement on semi-precast slabs (100%). Concreting over semi-precast slabs (100%).
- iv) Wing D - Lay fabric reinforcement on semi-precast slabs (100%). Concreting over semi-precast slabs (100%).

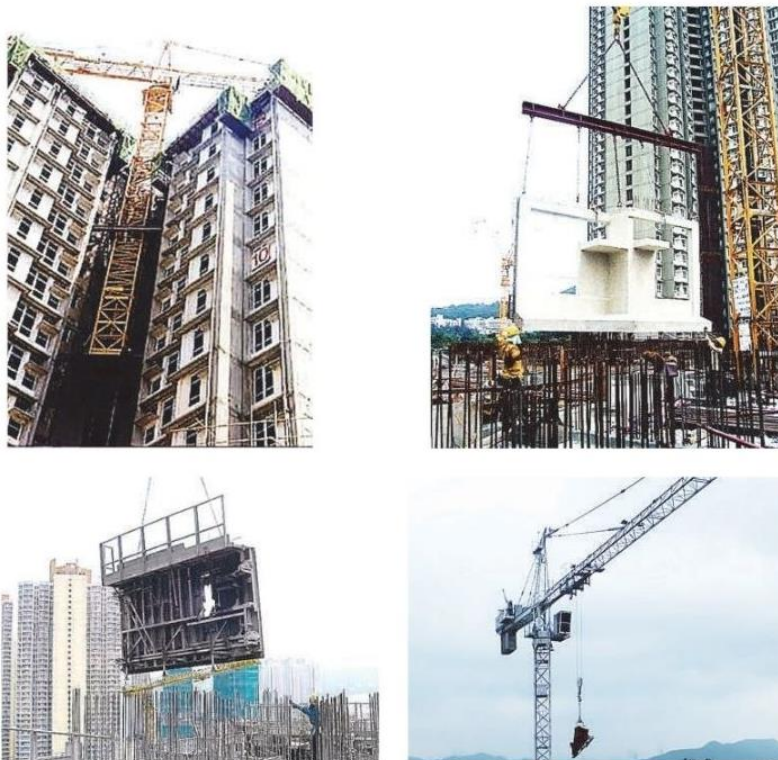
The six day construction cycle hinges very much on the tower crane. The latter is basically fully occupied throughout the day in transporting precast elements, formwork and concrete skip, plus the other construction materials such as partition walls, reinforcement, equipment, etc. (see Fig. 62).

Fig. 62 Tower crane is heavily occupied

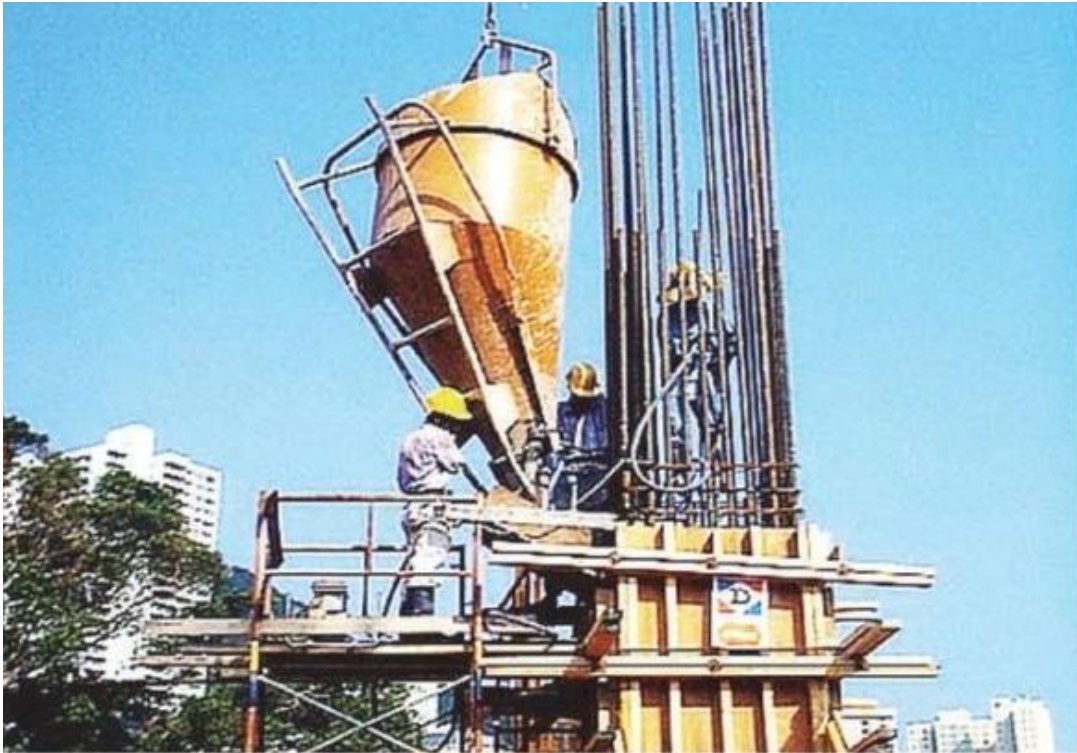
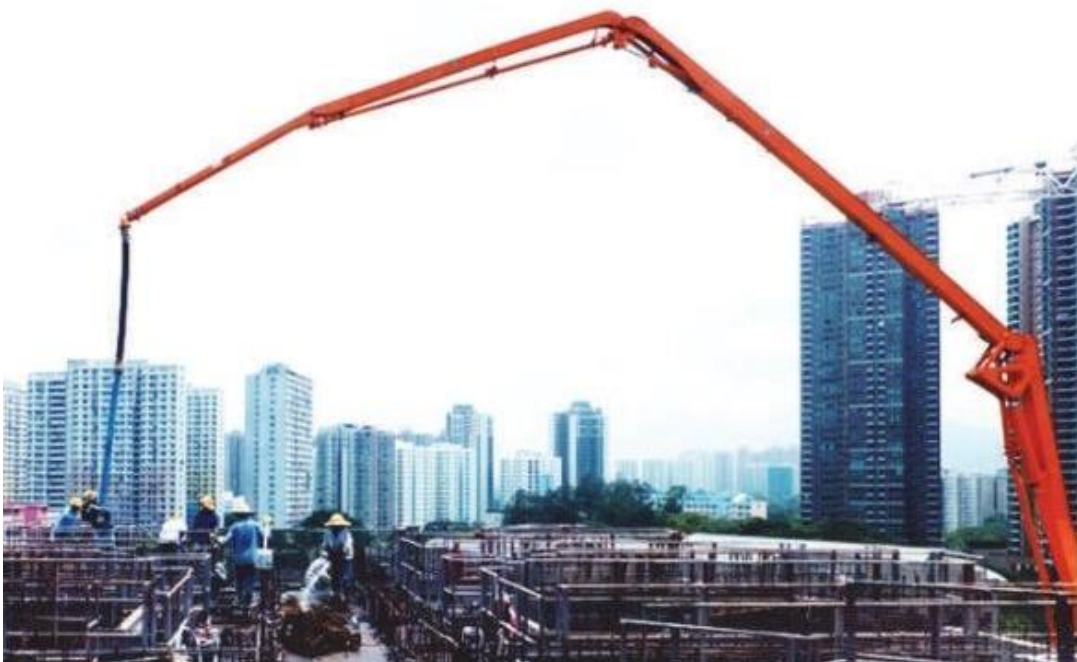
It can be found that there are idling time every day in some of the wings of the block, basically waiting for the tower crane. In order to better utilize the tower crane and hence shorten the cycle time, one effective method is to use pumped concrete which could spare the time of transporting the concrete skip by the tower crane (see Fig. 63). As a result, a 5-day cycle can be achieved.

Fig. 63 Replacement of concrete skip with pumped concrete

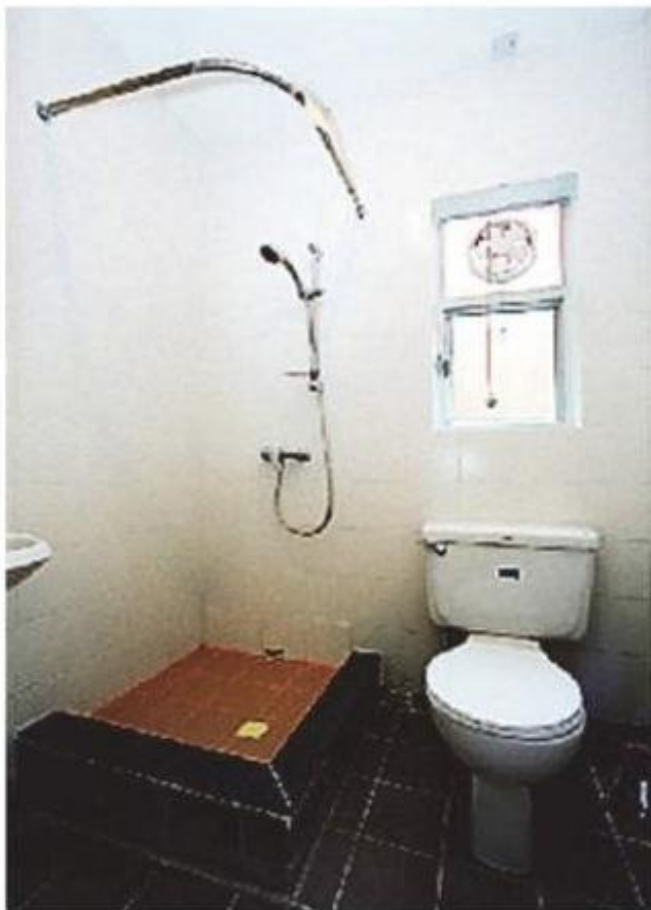
Fig. 65 Wet trade transferred to factory

- i) Fair face off-form finishes minimizes touching up and repair, which is very frequent for timber construction (e.g. slab soffit and wall finishes).
- ii) Labor cost in precast factory is much lower than that for in-situ construction, first because cost is cheaper in Mainland China and second semi-skilled labor in factory instead of skilled labor at working floor is required.
- iii) In-situ architectural wet trade, such as block works partitioning, tiling, plastering, etc. (see Fig. 65) are substantially reduced, mostly transferred to factory or eliminated through the use of metal formwork.
- iv) Mechanized construction demands much less labor than those of conventional timber construction, particularly in terms of carpentry and temporary works.
