**Modular Integrated Construction (MiC) for
High-rise Public Residential Housing in Hong
Kong: its Building Design, Construction, and
Maintenance Management**

A THESIS

Faculty of Engineering & Technology
in fulfillment of the requirements
for the degree of Doctor of Philosophy
in Construction and Real Estate Management
2025

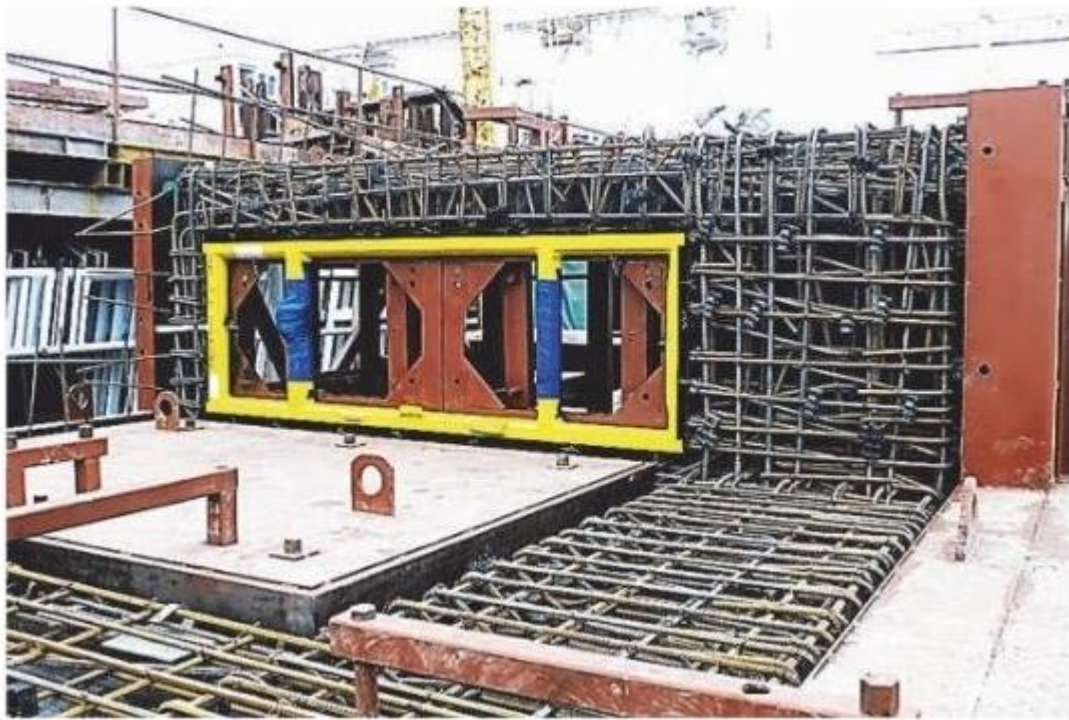
- i) window leakage – through precast construction, windows are cast into the facades which eliminate regular maintenance (see Fig. 66).
- ii) plumbing and drainage – again through volumetric precast whereby pipes and ducting are cast in factory (see Fig. 67).

Fig. 66 Cast-in windows

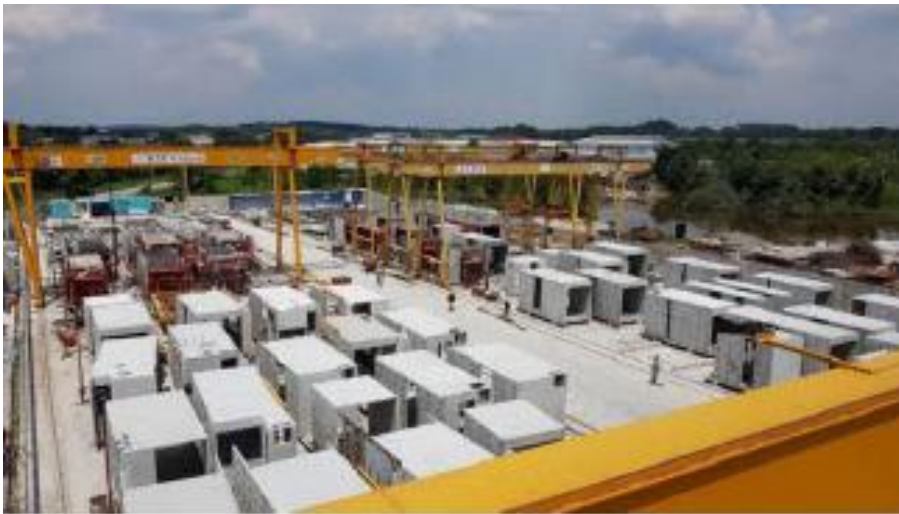
Fig. 68 Significant investment for factory to produce MiC modules

- Six active factories currently providing PCCs to HA (Few have concrete MiC experience)
- Require upgrading of hoisting gantries
- Large storage for modules

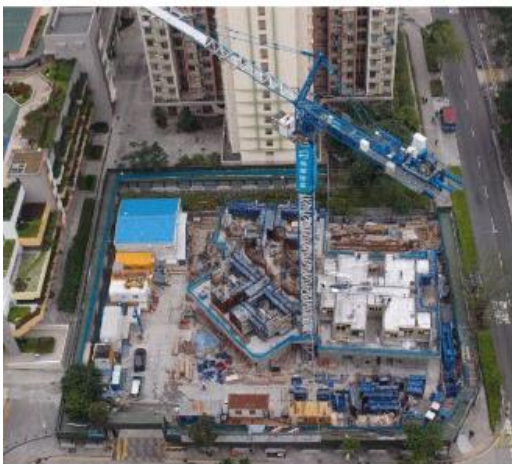
Fig. 69 Limited site storage for Housing Authority (HA)'s developments

- Congested sites with limited temporary storage area for large scale MiC modules

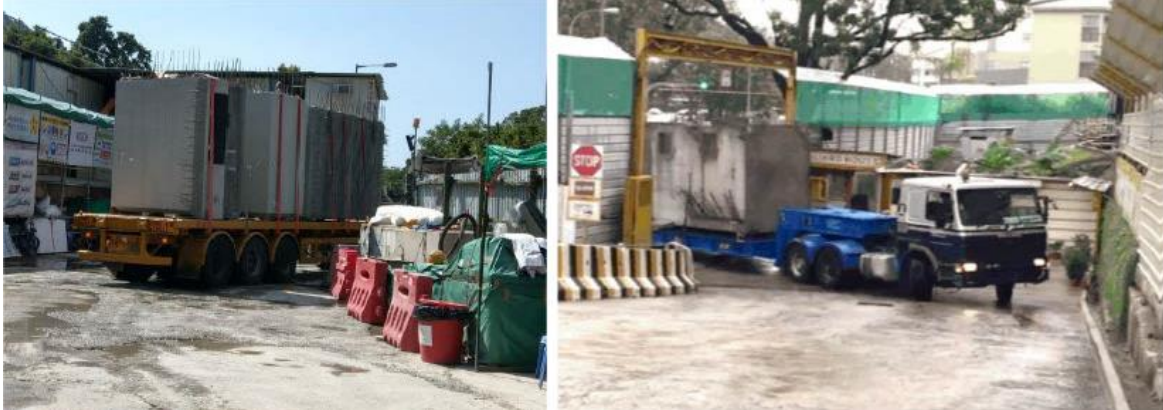
Fig. 70 Site constraints and road access restriction

- Nearby site constraints and road access restriction (e.g. narrow road) hinder the delivery of MiC modules

- Cap 374G Road Traffic (Traffic Control) Regulation 55 • Height not exceeding 4.6m • Starter bar < 32dia

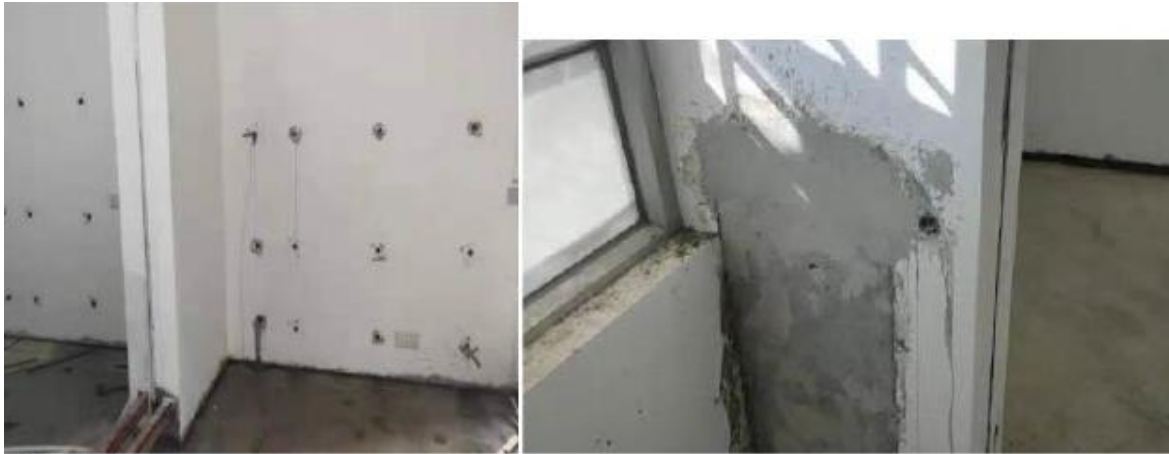
Fig. 75 Additional touch-up works

- MiC has notable benefits for projects involving substantial finishes and fitting works.
- HA's developments are of no-frills design without sophisticated fittings and finishes.
- Damage of pre-apply painting within and outside flat.
- Re-apply painting after installation of modules and concreting required.
