**QUALITY MANAGEMENT DURING IN-SITU  
RECONSTRUCTION OF FAILED SICKLE PLATES  
BY WELDING AT UNDERGROUND PENSTOCK  
OF SRISAILAM LEFT BANK HYDRO ELECTRIC  
PROJECT – A CASE STUDY**

By  
Rama Dasu Pittala

**A DISSERTATION**

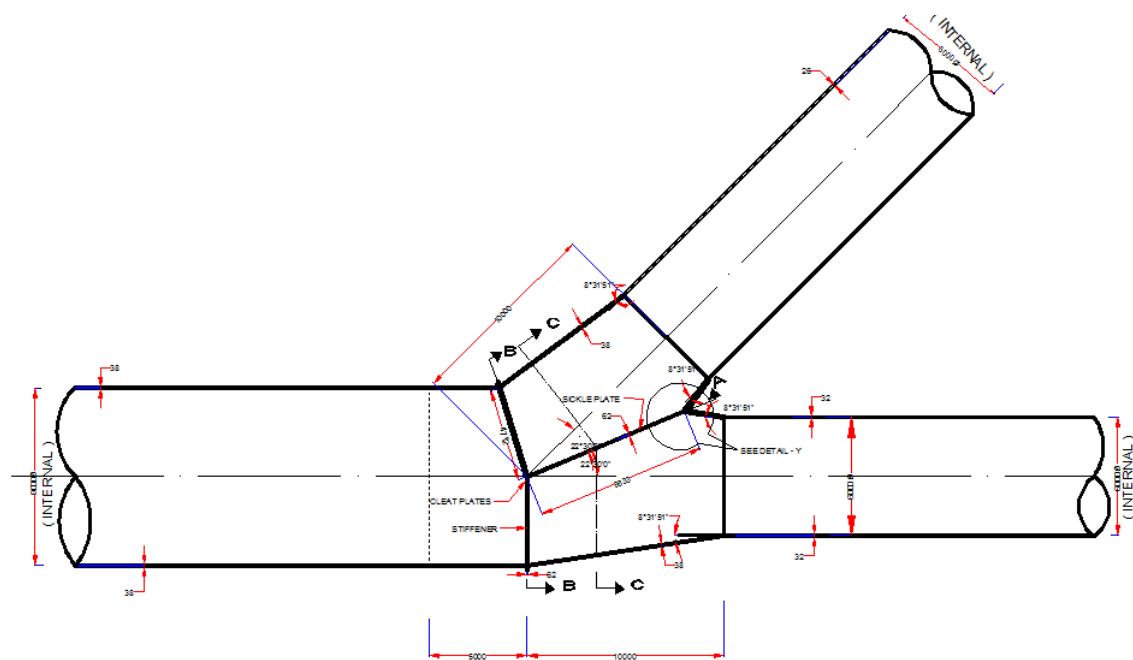
Fig.1 [2] Location & Construction details of Sickle Plate – Plan

On 11<sup>th</sup> Oct 2008 around 6.00Am, heavy vibrations were observed in Unit 2 during service. Draft tube was emptied and when examined inside, part of Sickie-plate at bifurcation between Units 2 & 3 was found stuck-up in the spiral casing of Unit 2 . ( Ref Fig.1 )

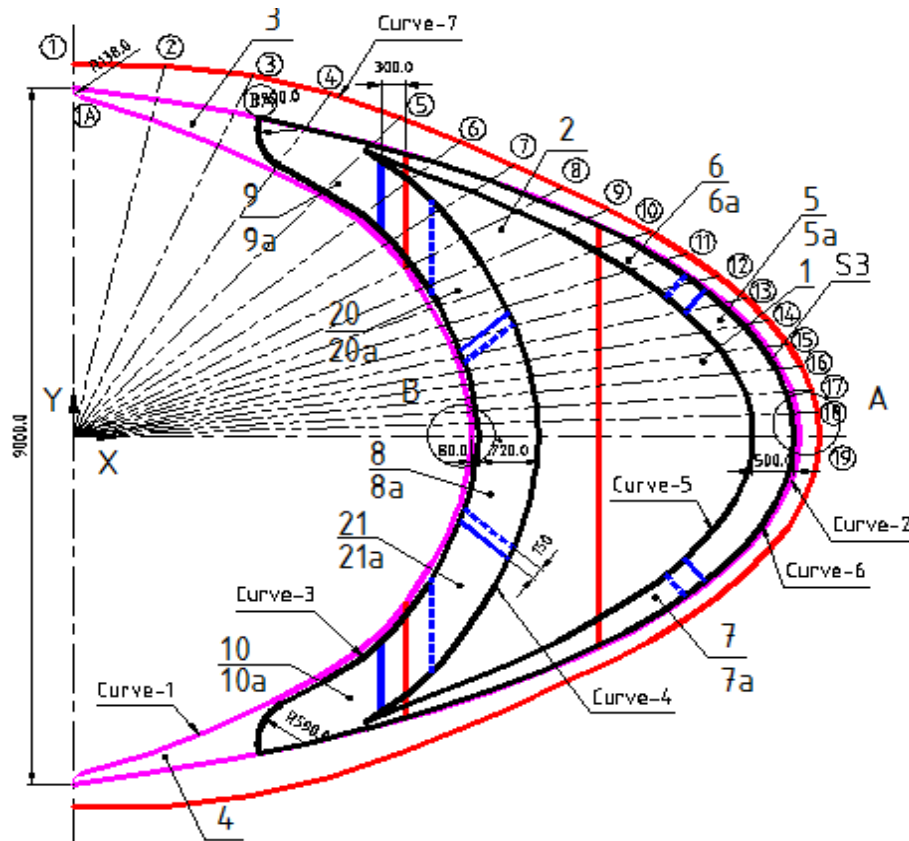
Fig.7 [3] –Location of Weld Joints, Shown in Red-Vertical and Blue

For the patch plates there is overlap between similar welds located in the opposite faces (ref.Fig.7). The *Weld sequence* was prepared to minimize residual stresses and distortion (ref.Fig.8). [8] Weld sequence Document is given as Annexure I.

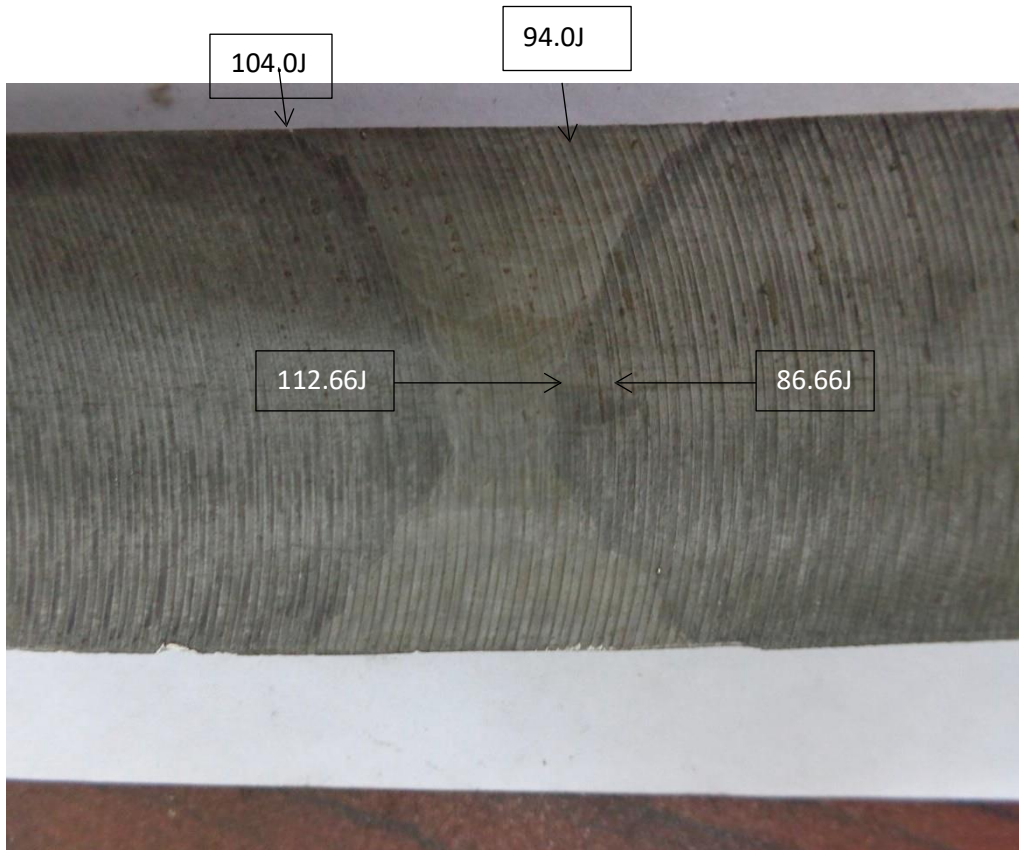
**Charpy V notch location and Average impact strength**

Transverse Tensile Properties			Charpy Impact Strength in J, tested at $-29^{\circ}\text{C}$ ( lateral exp. in mm),27min			Remarks
	* YS in N/mm <sup>2</sup>	UTS in N/mm <sup>2</sup>	* % El	HAZ	Weld	Location of sample	
T1A	718.43	738.13 $\sigma$	17.2	104 (1.0), 114 (0.9), 94(0.9); Av: 104 110 (1.3), 66 (0.7), 84(0.8), Av:86.66	82 (0.9), 104 (1.0), 96(0.9) Av: 94 148 (1.4), 76 (0.6), 114(1.0) Av:112.6 ;	Outer fibre	1) *YS and %El are for information only. 2) 4 Nos Side Bend test – satisfactory. 3) $\sigma$ UTS is 91.84-95.08% of minimum UTS of ASTM 517 Gr F requirement (795- 930 N/mm <sup>2</sup> )
T1B	725.59	755.85 $\sigma$	20.0				
T2A	690.25	740.18 $\sigma$	19.0			Core	
T2B	702.80	730.14 $\sigma$	17.8

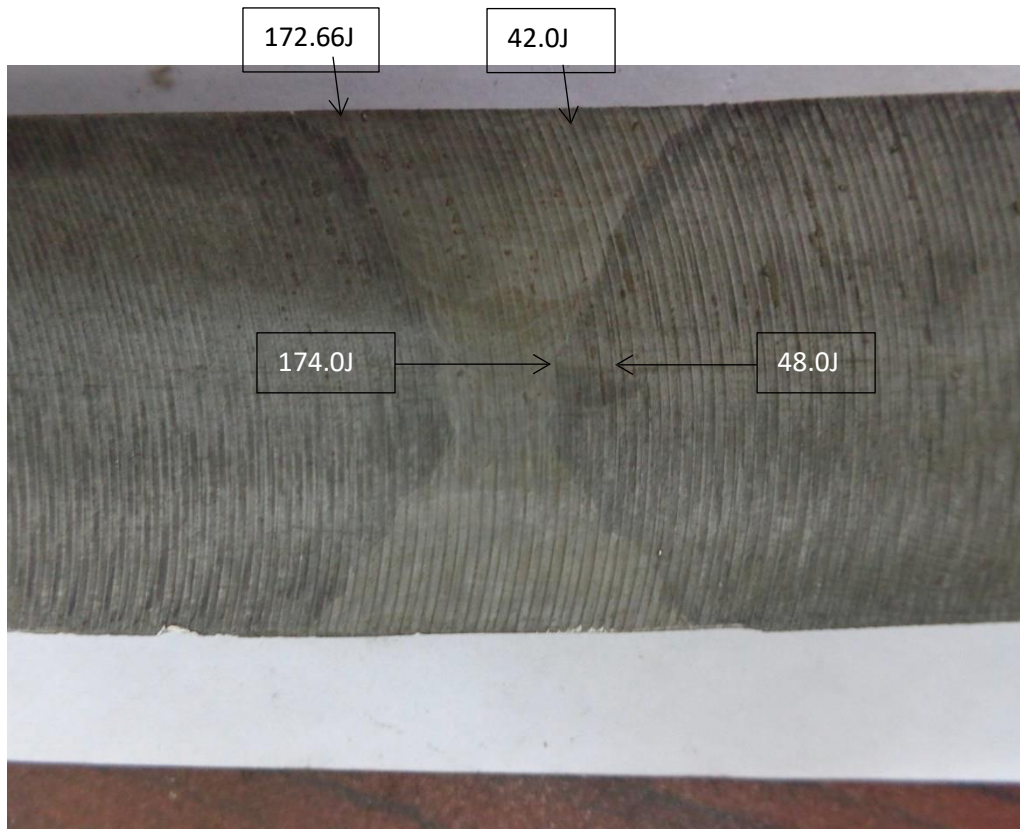
**Charpy V notch location and Average impact strength**

Transverse Tensile Properties			Charpy Impact Strength in J, tested at -29°C ( lateral exp. in mm) 27 min			Remarks
	*YS in N/mm <sup>2</sup>	UTS in N/mm <sup>2</sup>	*% El	HAZ	Weld	Location of sample	
T1A	745.91	818.14	20.8	162 (1.4), 176 (1.5), 180(1.6) Av:172.66 140 (1.4), 188 (1.5), 194(1.6) Av:174.00	44 (0.6), 46 (0.6), 36(0.5) Av:42.00 50 (0.7), 72 (0.8), 48(0.6) Av:56.66	Outer fibre	1) *YS and %El are for information only. 2) 4 Nos Side Bend test – satisfactory. 3) UTS is meeting the requirement of ASTM 517 Gr F (795- 930 N/mm <sup>2</sup> )
T1B	802.94	836.34	22.0				
T2A	784.26	834.12	19.2			Core	
T2B	791.20	847.16	19.6

- All the properties including transverse UTS is meeting the requirement of ASTM A 517 Gr F material for the WPS No.PES/SLBHES/E9018M-11018M/2013-14 Rev0 in which the combination of electrodes E9018M for root and filling followed by E11018M for capping were used.
- In case of WPS No.PES/SLBHES/E8018C3-11018M/2013-14 Rev0 using the combination E8018-C3 for root and filling followed by E11018M for capping, the transverse UTS was found to be about 92-95% of the minimum UTS required for ASTM A 517 Gr F material.

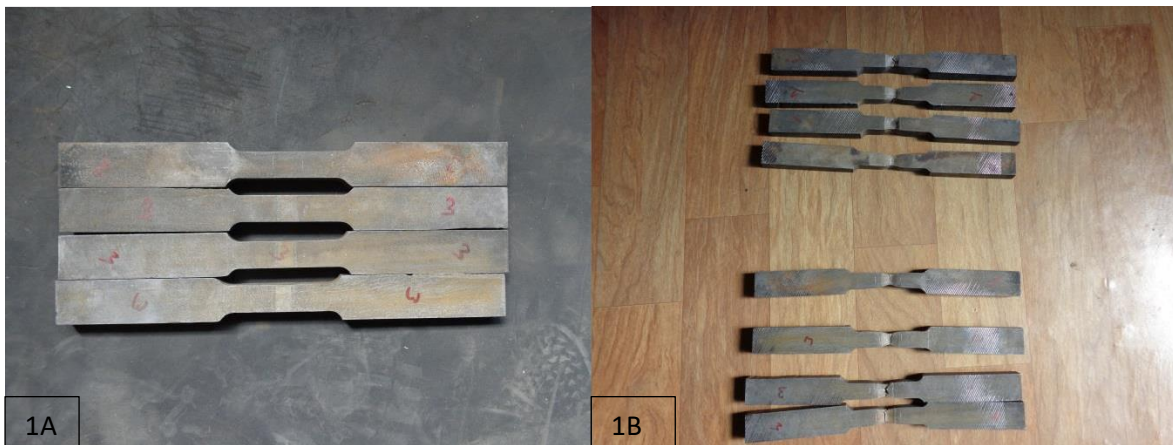
1A & 1B - Tensile Samples , before testing, and after testing. Ductile Fracture in weld can be seen.
